Your Inspection Report

SEWER SCOPE REPORT Atlanta, GA

PREPARED BY:
Chandler Stansell

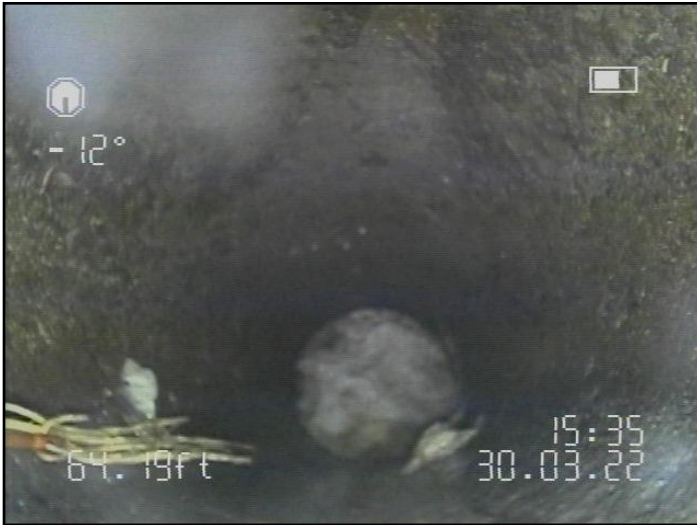
WASTE PLUMBING \ Drain piping**1. Condition:** • Root Growth

There is root growth present which is commonly a result of a damaged drain line. We recommend further review and repair as needed.

1. End of Root Growth at 64.19'.

Task: Consult with a qualified plumber

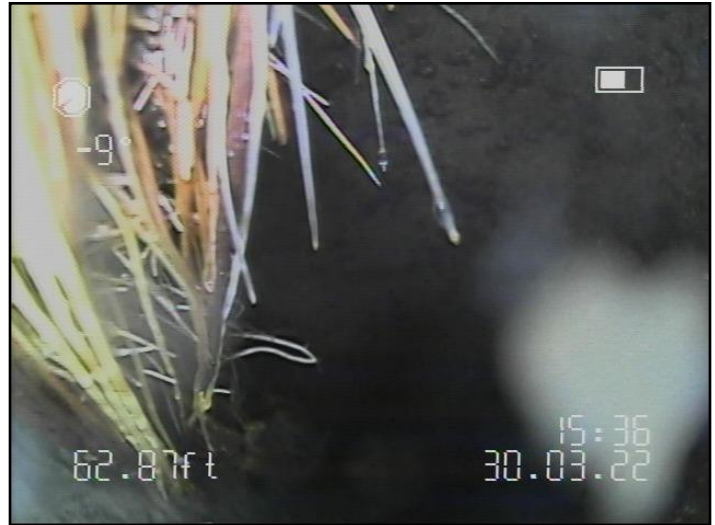
2. Continued Root Growth at 62.87'.

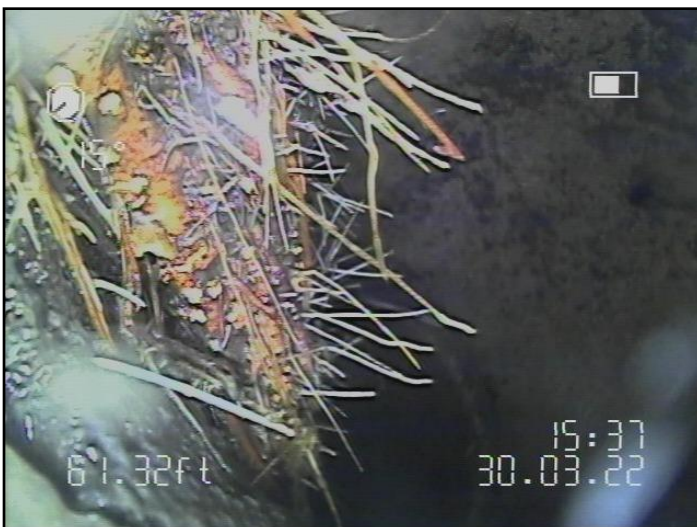
3. Continued Root Growth at 61.32'.

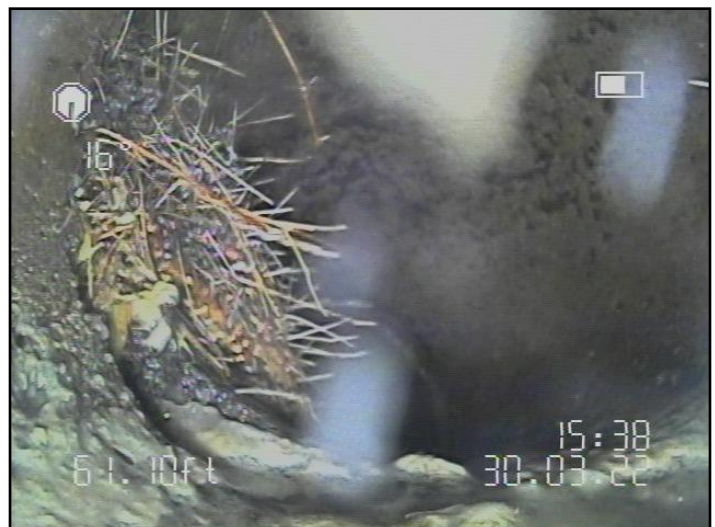
4. Start of Root Growth at 61.10'.

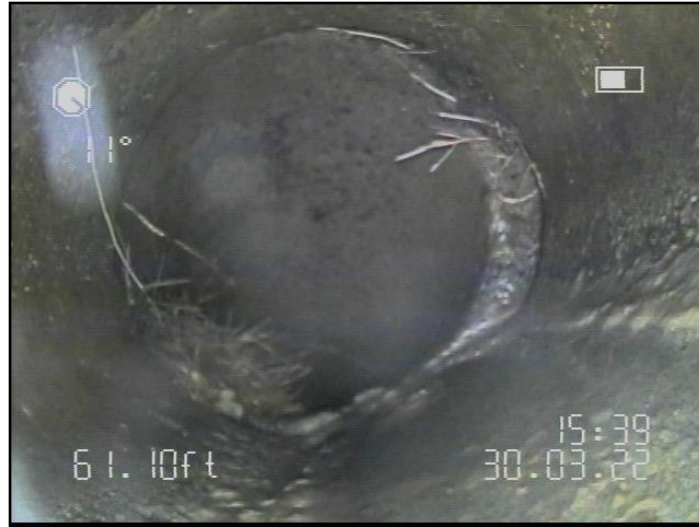
2. Condition: • Offset

There is an offset in the drain line where two pipes are not properly connected and there is a "lip" which can cause clogging. We recommend further review and repair as needed.

5. Offset at 61'.

Task: Consult with a qualified plumber

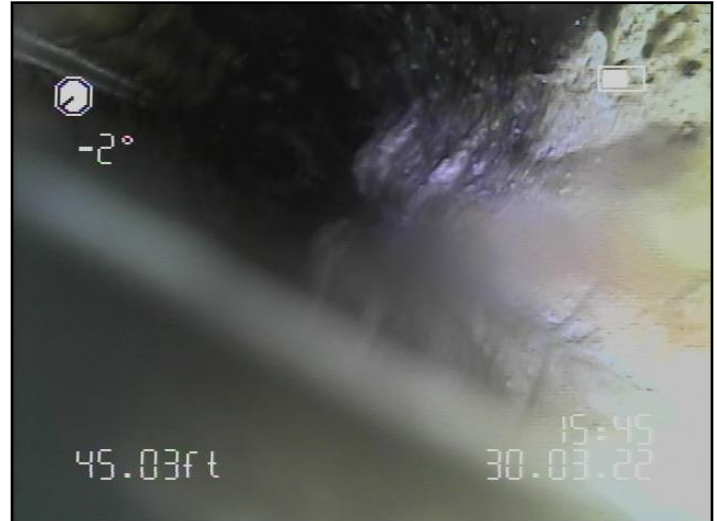
7. Belly/Settling in pipe at 45.03'.

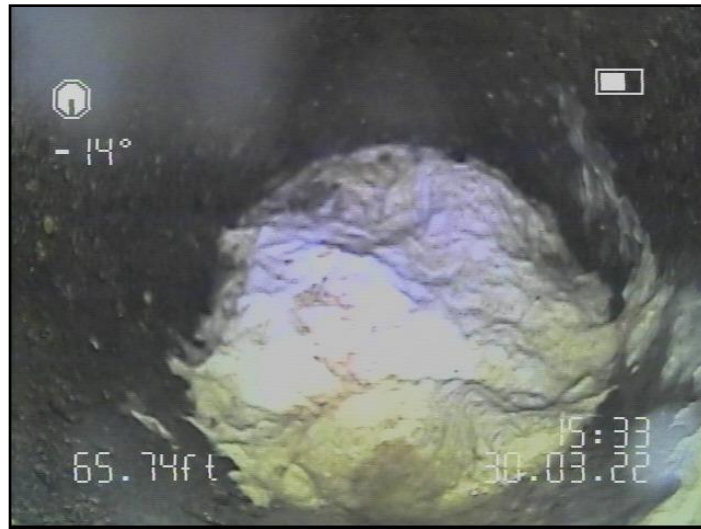
4. Condition: • Debris/Blockages

There is evidence of debris or blockages within the sewer line. This can cause backups and further complications.

8. Debris/Blockage at 65.74'.

Task: Consult with a qualified plumber

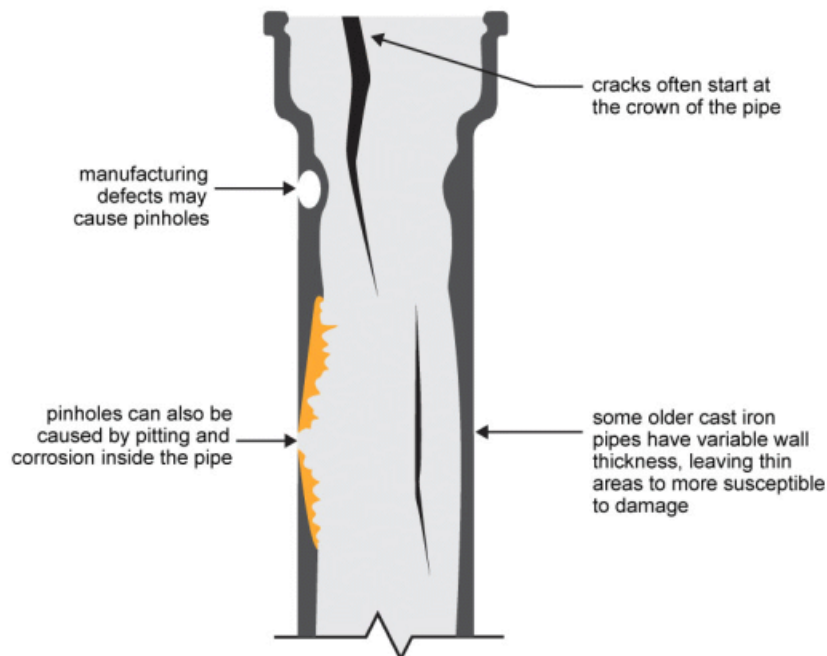
5. Condition: • Cast Iron drain line is present and has an average expected life of 40 - 60 years. Most Cast Iron in use will be near the end of its expected life and may require repairs or replacement in the near future.

Pinholing and cracks in cast iron stacks

Task: Consult with a qualified plumber

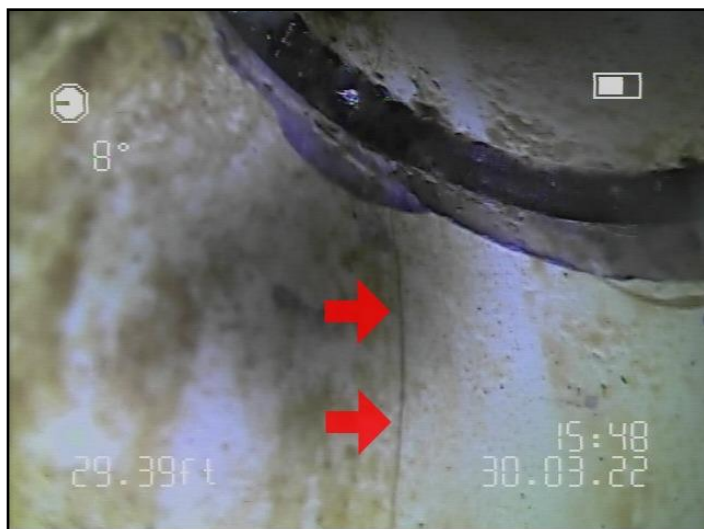
6. Condition: • Hairline Cracking

9. Cracking at 29.39'.

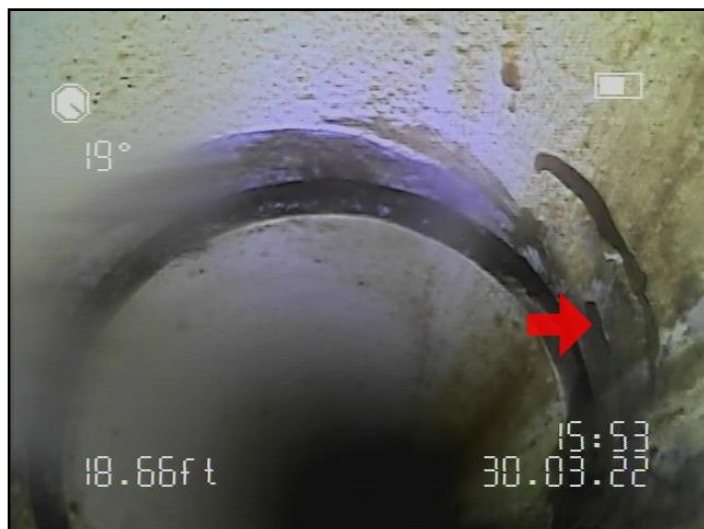
10. Cracking at 18.66'.

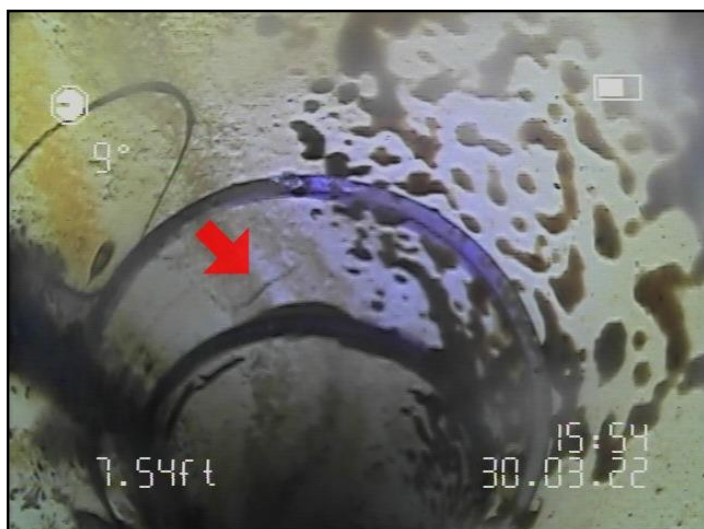
11. Cracking at 7.54'.

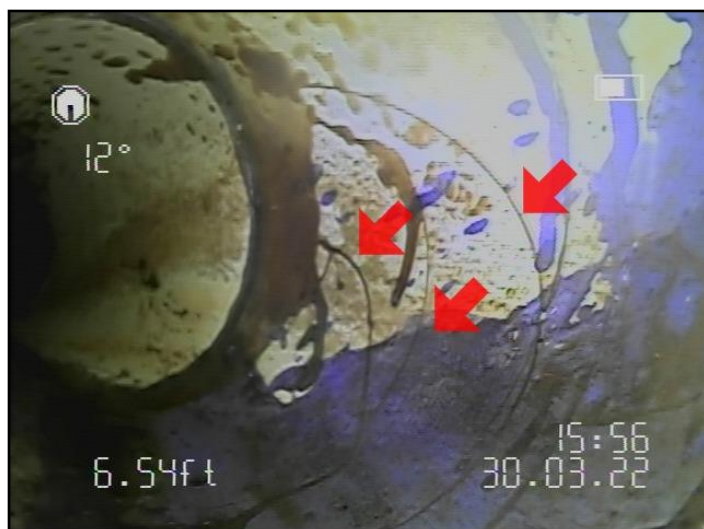
12. Cracking at 6.54'.

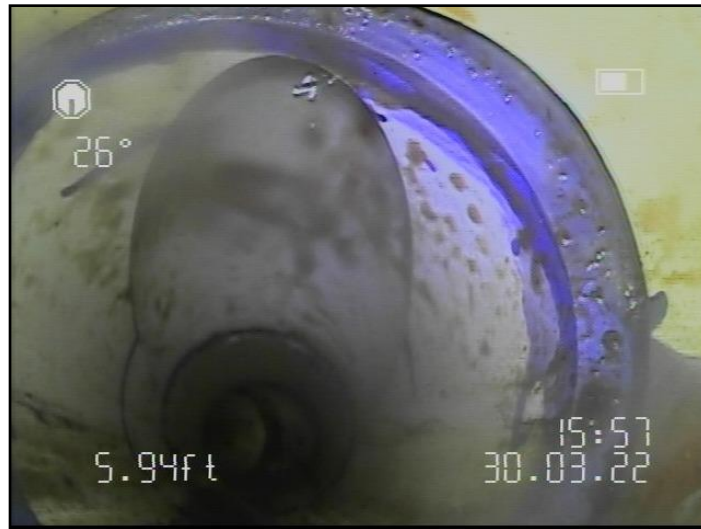
13. Junction at 6'. Origin unknown.

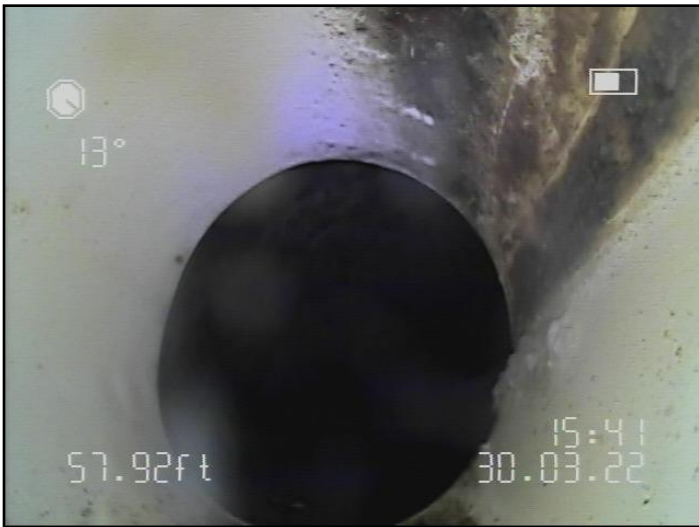
14. PVC to Cement at 58'.

Waste piping material: • PVC waste line typically has an expected lifespan of 100 years or more. • Cast Iron drain lines have an average expected life of 40 - 60 years • The presence of cement drain line may be the result of prior repairs - Recommend requesting disclosure and possible further evaluation.

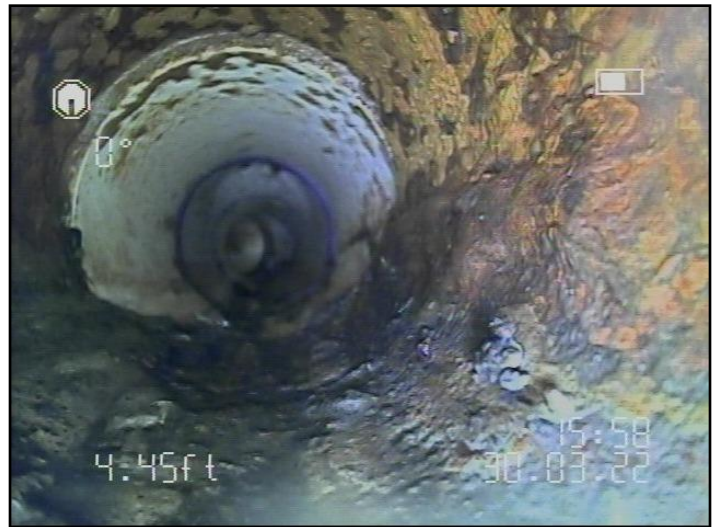
15. Cast Iron to PVC at 4.45'.

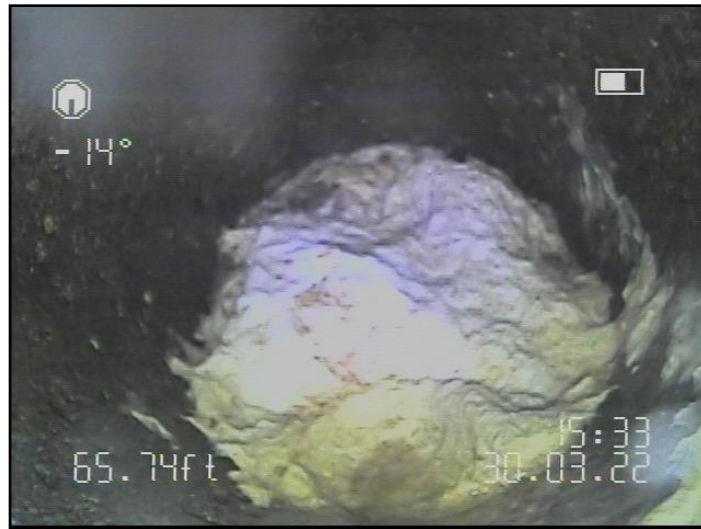
- The camera was not run to full capacity due to pipe obstructions

19. Debris impeding further progress at 65.74'.
