Your Inspection Report

6695 Juliet Drive with THERMAL
Atlanta, GA 30328

INSPECTION DATE:
Monday, May 8, 2023

RE: Report No. 49158, v.2
6695 Juliet Drive with THERMAL
Atlanta, GA
30328

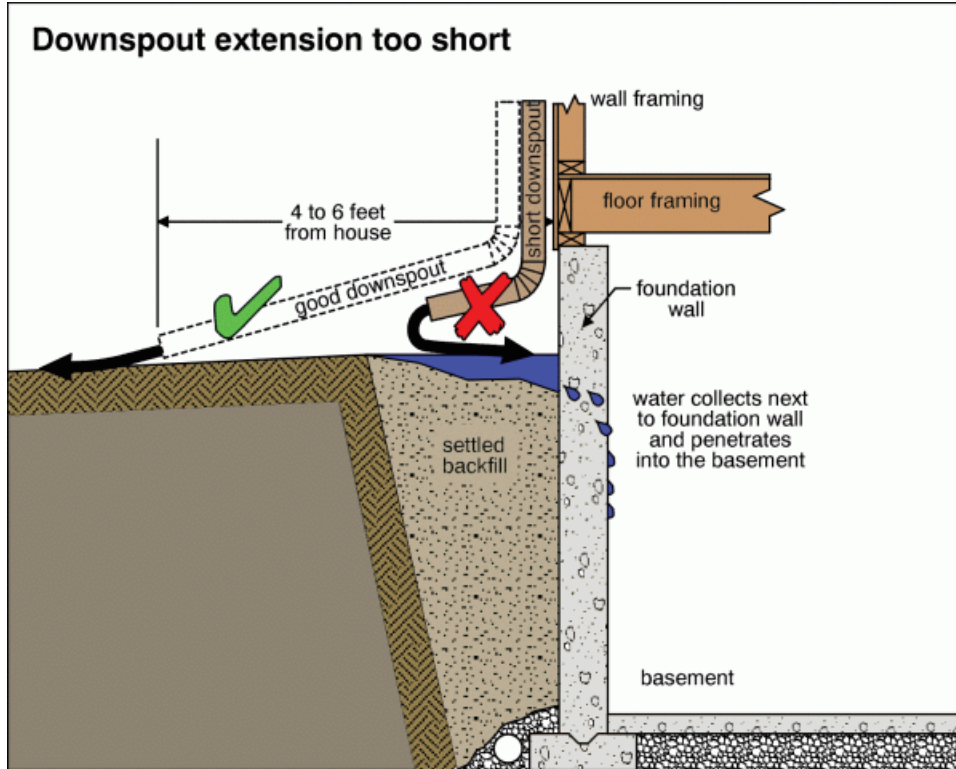
1. Condition: • Discharges Too Close to the Building

8. Discharges Too Close to the Building

Task: Extend downspout termination point at least 6 feet away from building, foundations, footings and slabs.

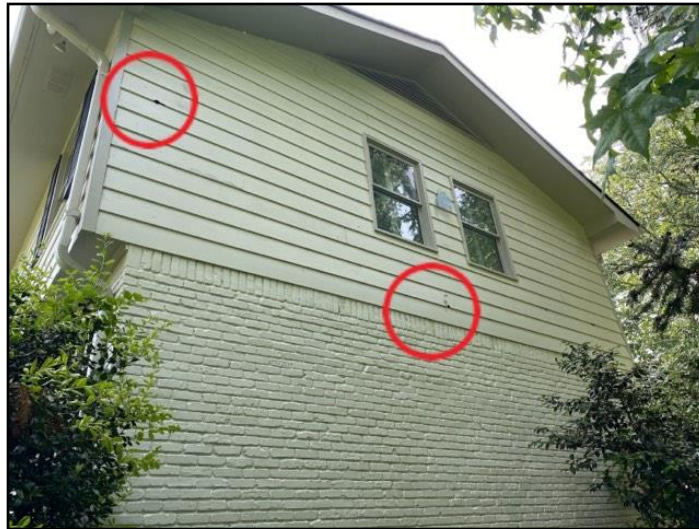
2. Condition: • Rot/Insect damage

In the process of repairing the areas outlined in this report, it is possible there will be additional areas requiring repair when the process has been started. The photos and locations noted in this report should only be considered representative of the condition and not all encompassing.

10. Rot/Insect damage

Task: Repair or replace

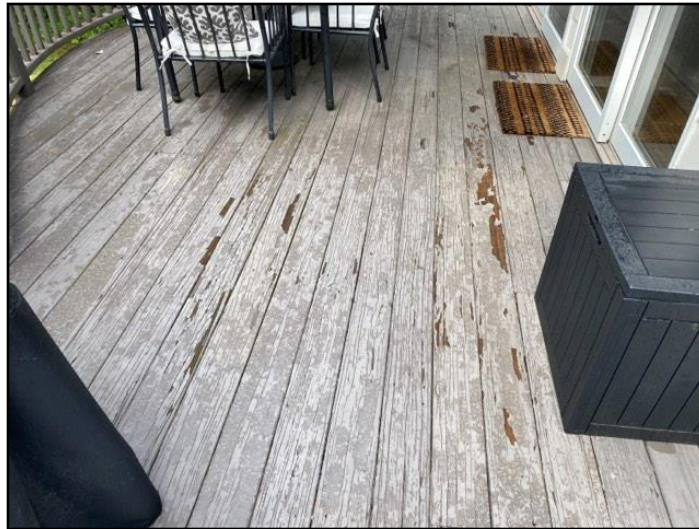
5. Condition: • [Maintenance needed](#)

11. Maintenance needed

Recommend re-paint/stain, re-setting fasteners and replacing warped/damaged/rotted deck boards as needed.

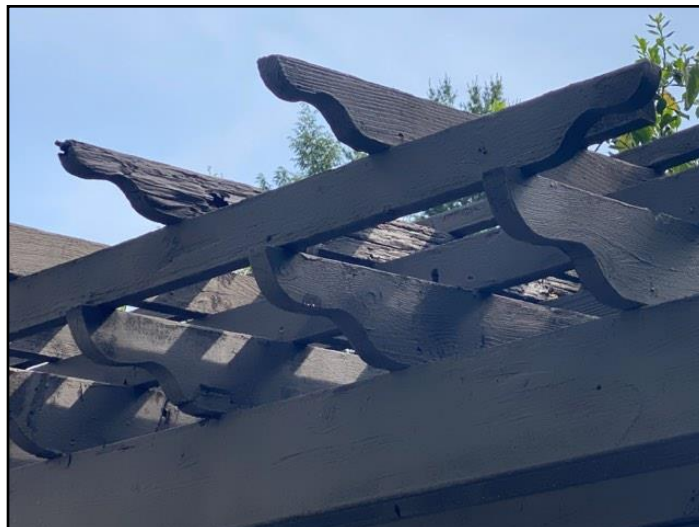
6. Condition: • [Rot/damage](#)

12. Rot/damage

Task: Repair or replace

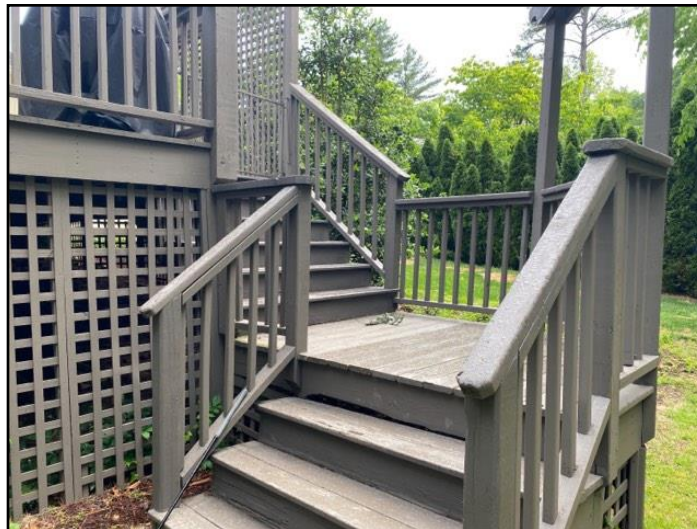
7. Condition: • Graspable Handrail Missing

13. Graspable Handrail Missing

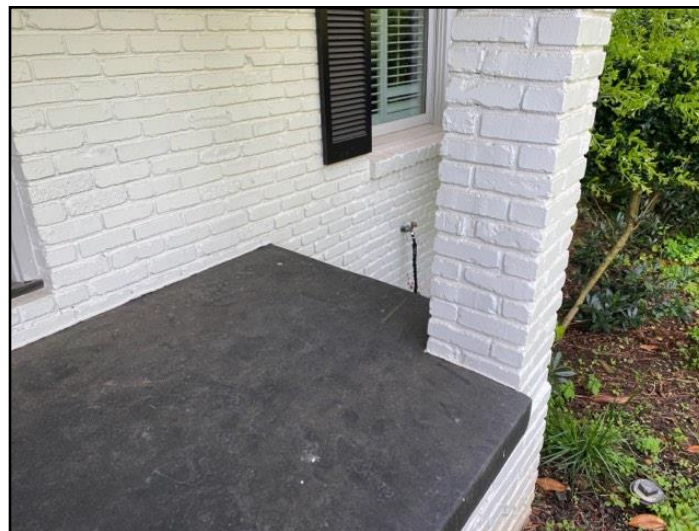
8. Condition: • Guardrail Missing

14. Guardrail Missing

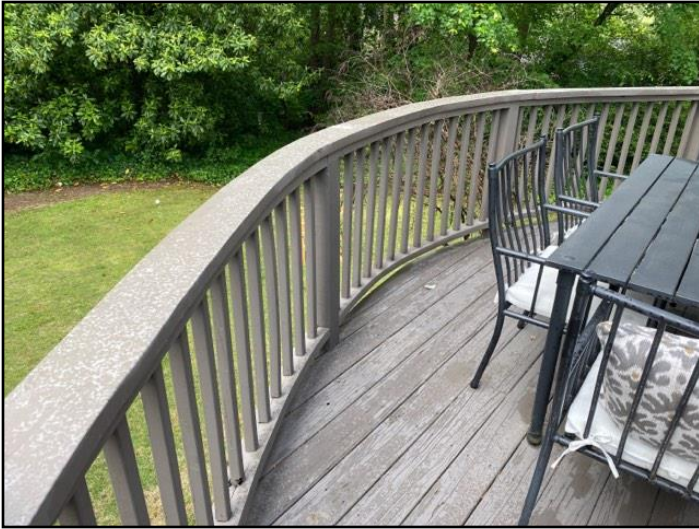
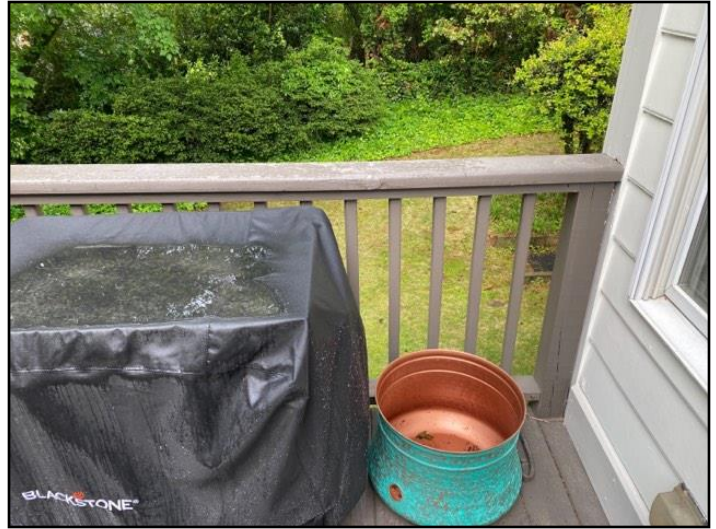
9. Condition: • Loose/weak Guardrail

15. Loose/weak Guardrail

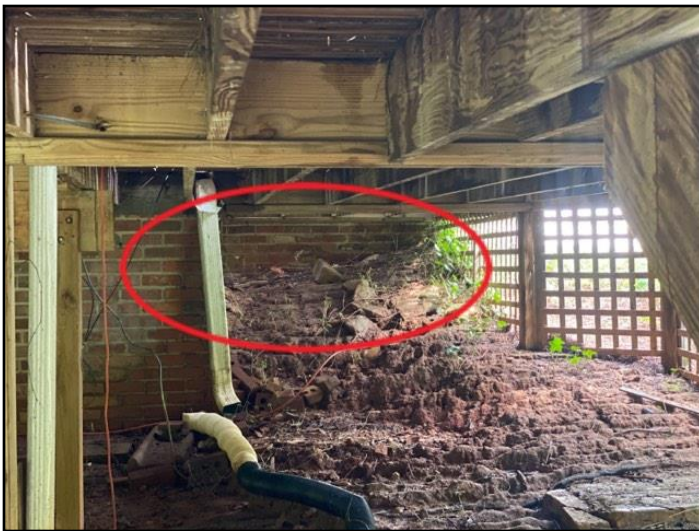
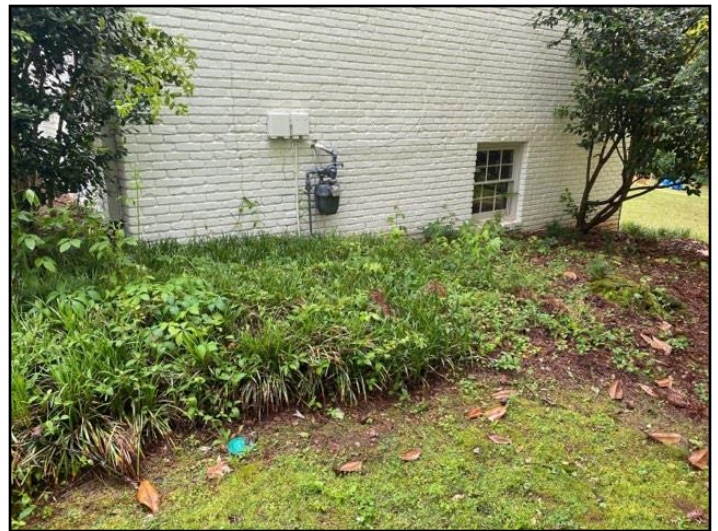
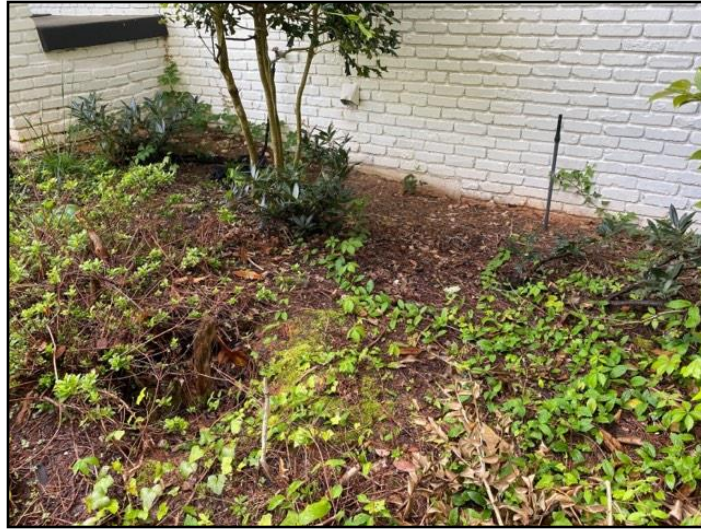
10. Condition: • [Improper Slope or Drainage - Click for DIY Video](#)

17. Improper Slope or Drainage - [Click for DIY...](#)

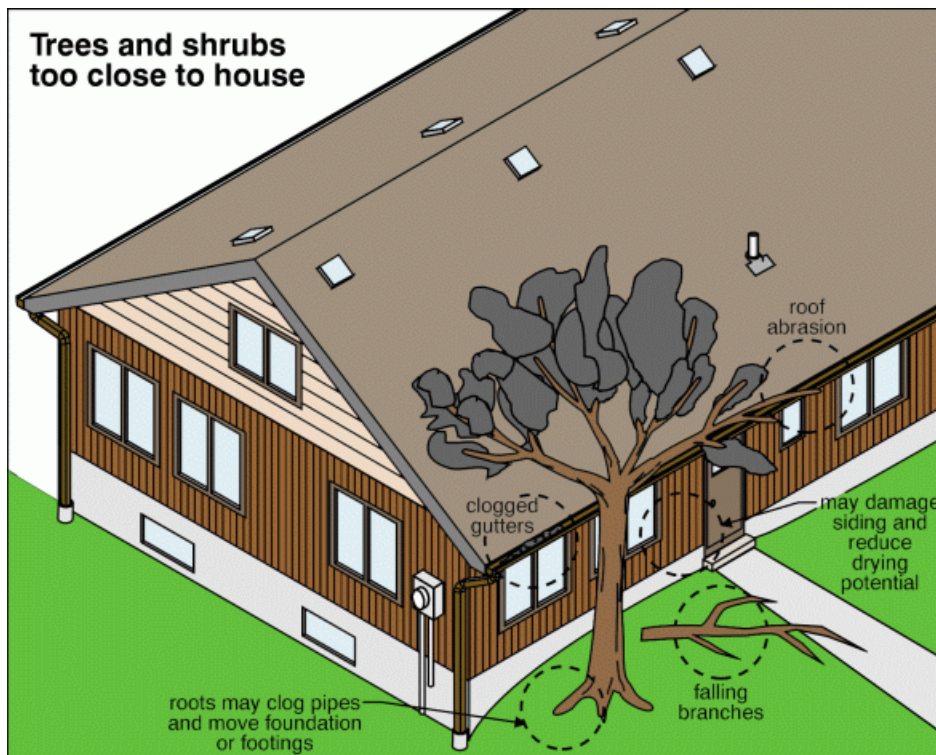
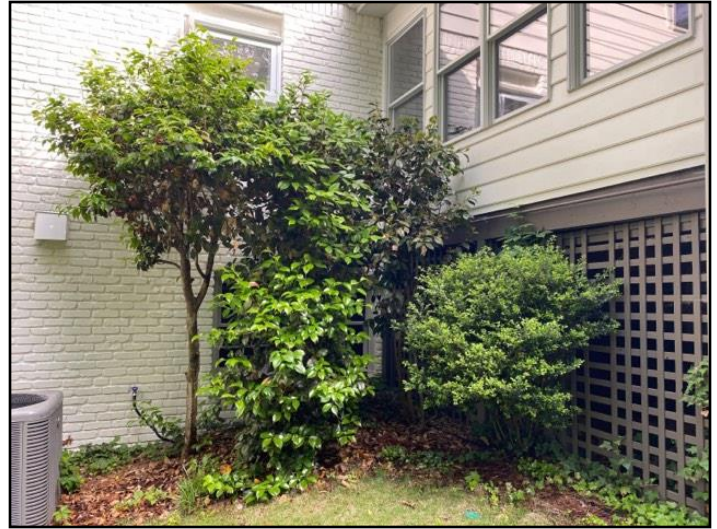
11. Condition: • Trees or Shrubs too close to building

20. Trees or Shrubs too close to building

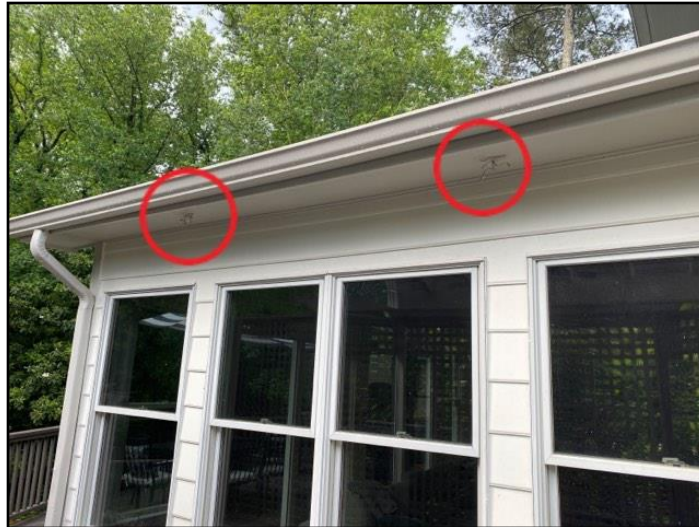
17. Condition: • Abandoned Wiring

Wire appears to be serving no purpose and should be removed to eliminate any possible safety hazard.

28. *Abandoned Wiring*

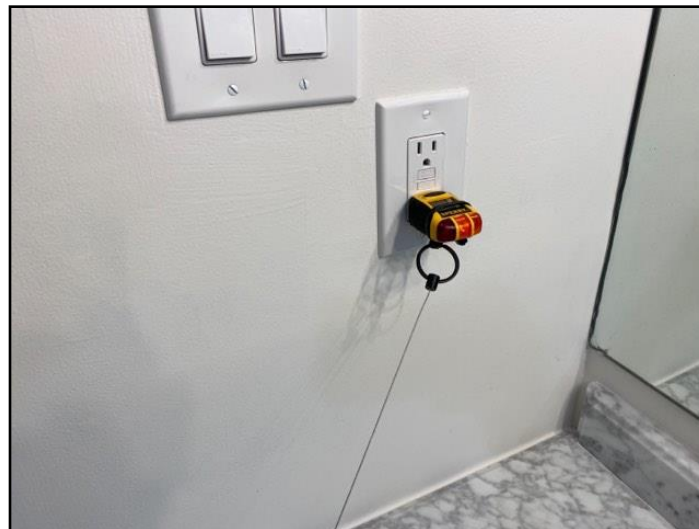
19. Condition: • Ungrounded

30. Ungrounded

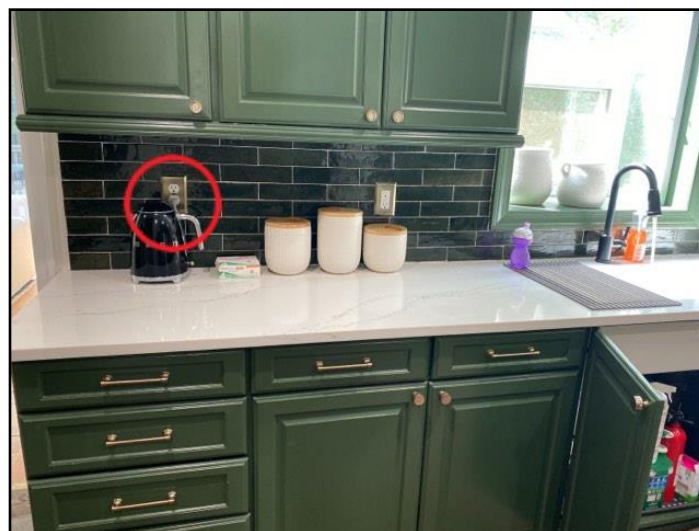
20. Condition: • No GFCI/GFI (Ground Fault Circuit Interrupter)

31. No GFCI/GFI (Ground Fault Circuit...)

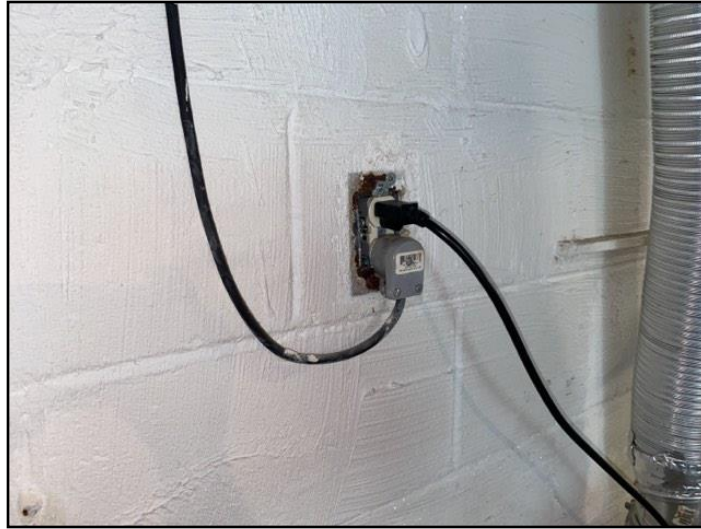
21. Condition: • Loose, missing, broken cover plate

32. Loose, missing, broken cover plate

Task: Replace

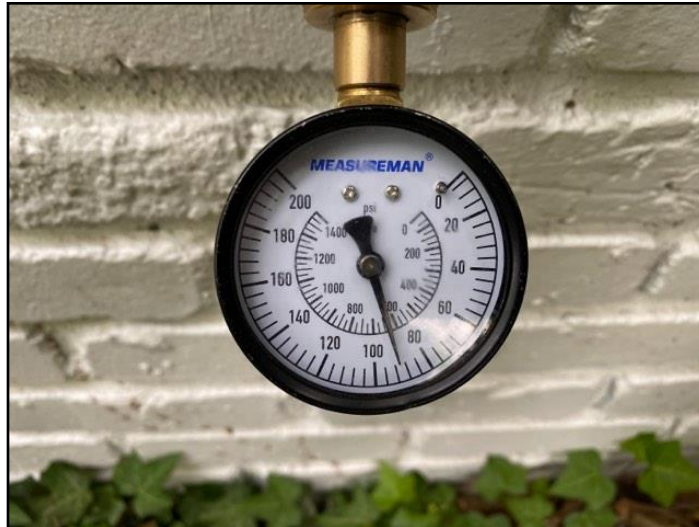
54. Set Wrong/Defective

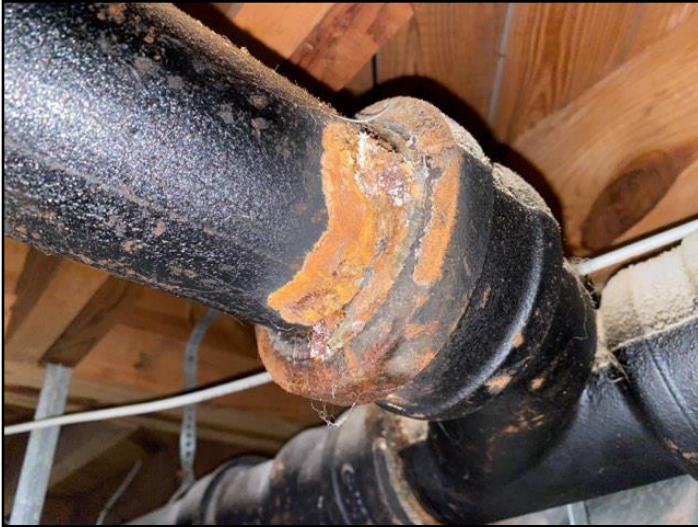
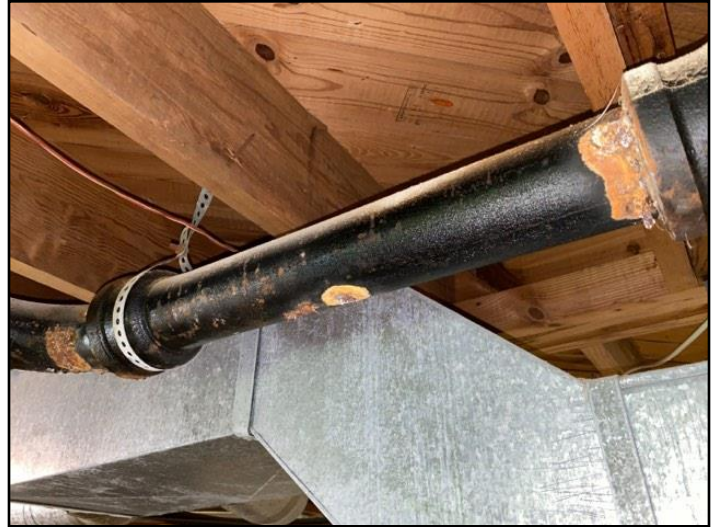
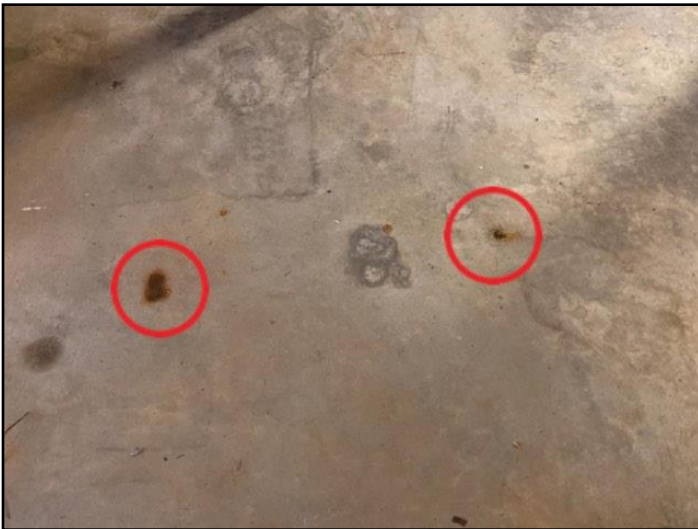
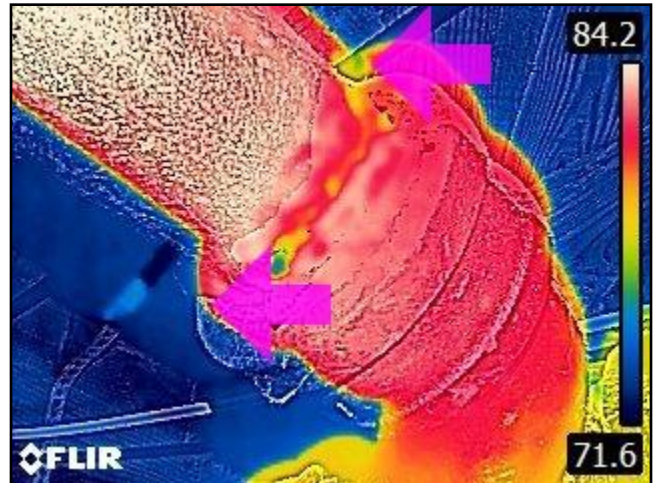
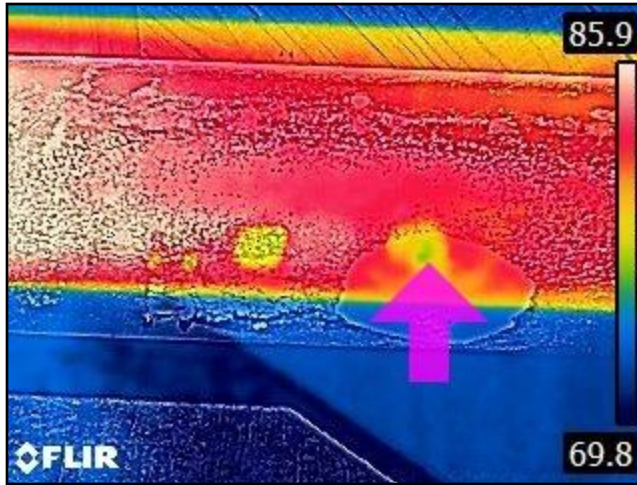
55. Leak

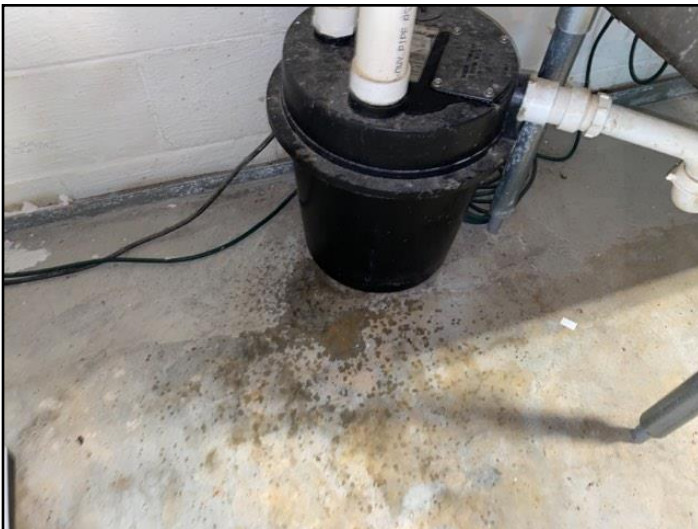
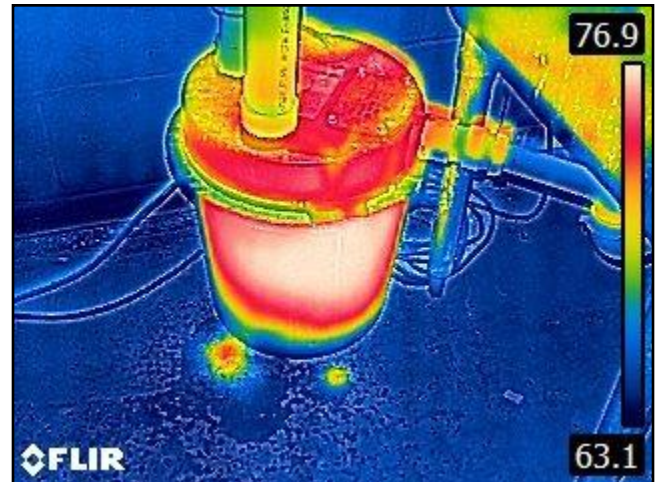
60. Leak

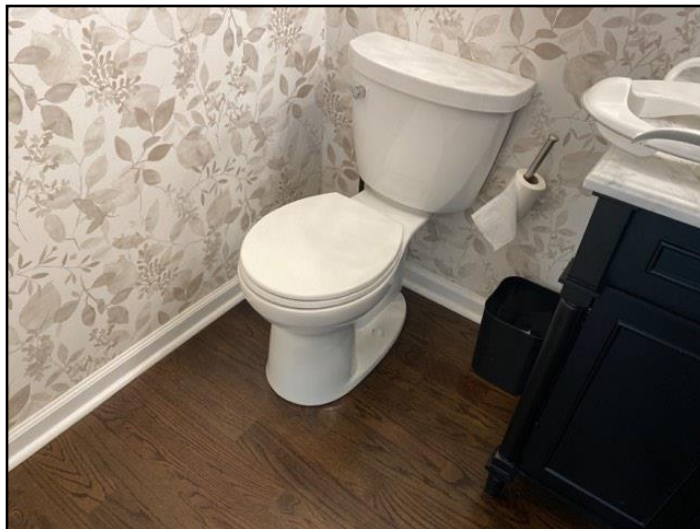
63. Loose

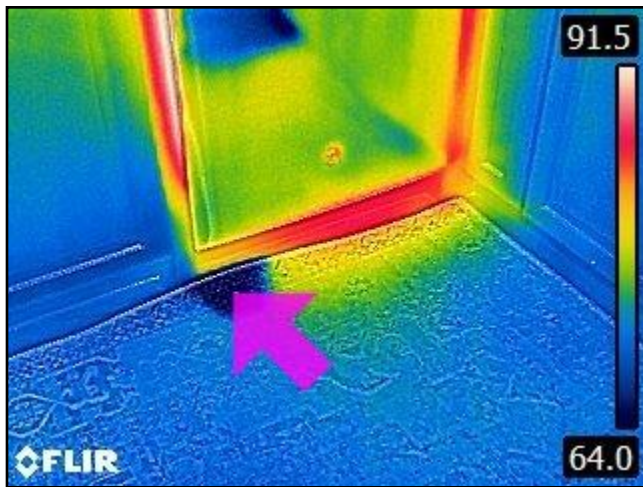
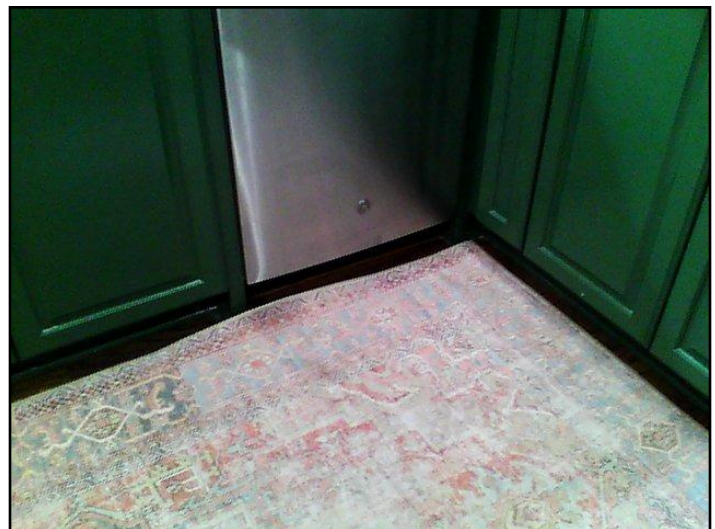
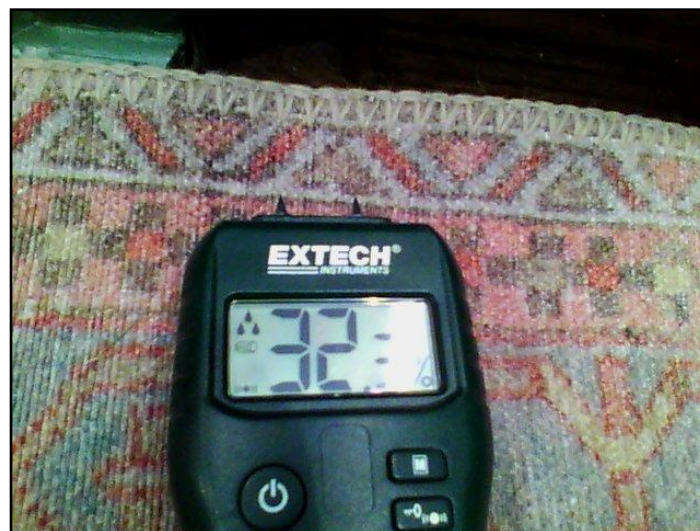
Anomalies indicate a moisture issue. Be advised while this is most likely an active issue, it may be evidence of a previous issue that has been corrected. Request additional information from seller regarding any prior issues, damage and/or repair before initiating further invasive inspection.

69. Anomaly Noted with Thermal Imaging Scan

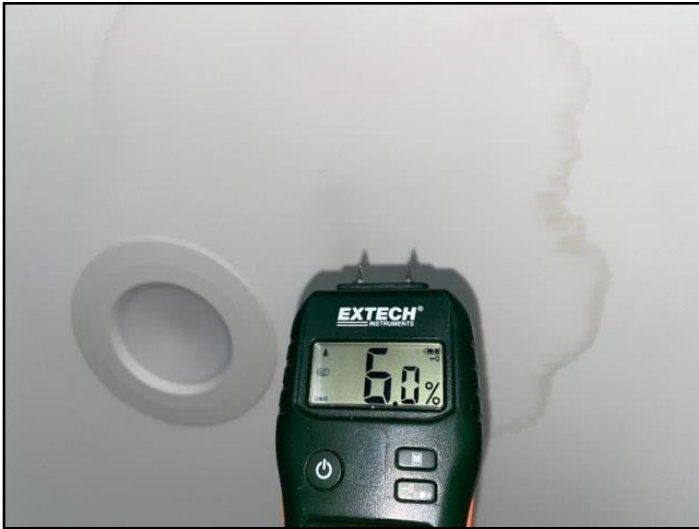
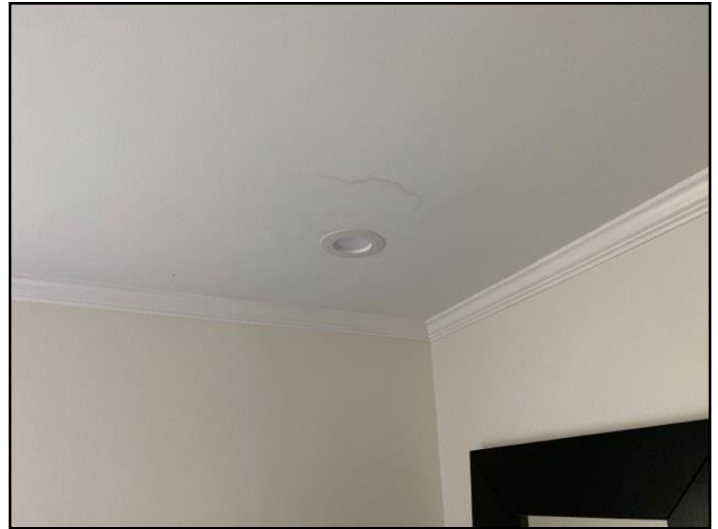
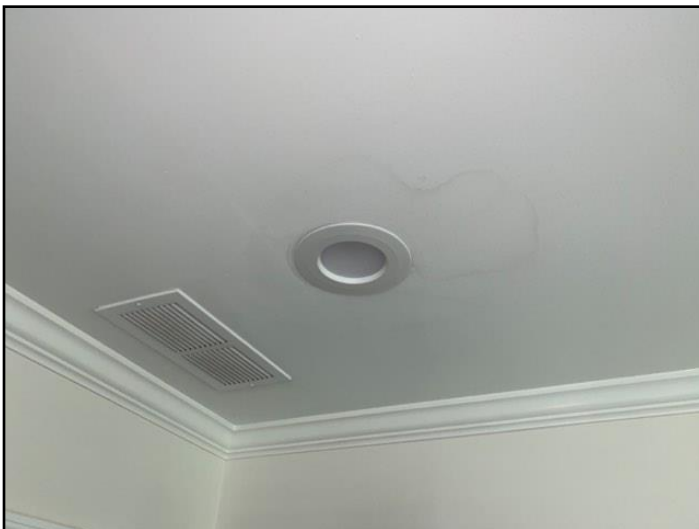
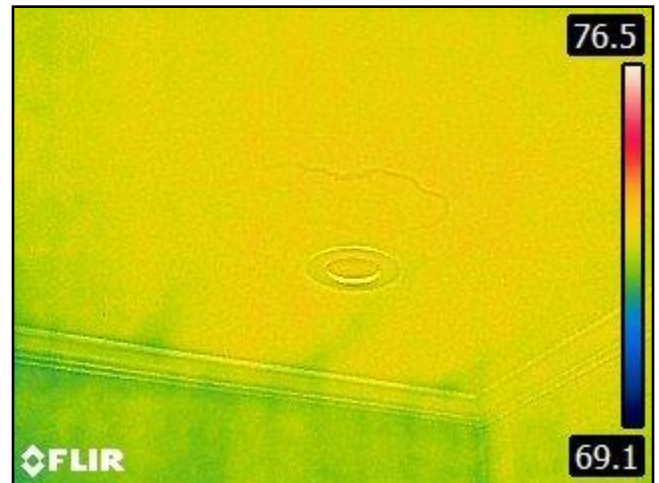
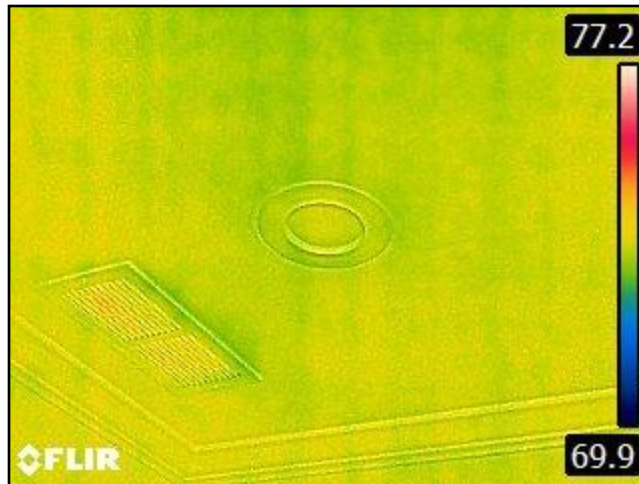
72. Stains noted were dry at inspection.

Task: Request disclosure

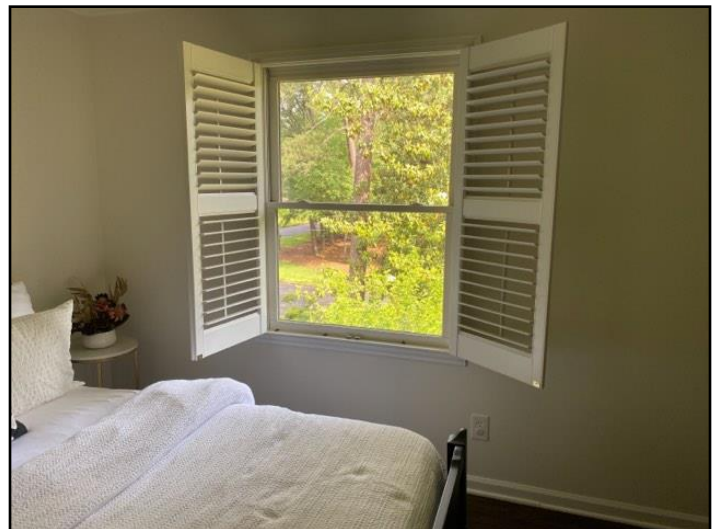
78. Windows Painted Shut

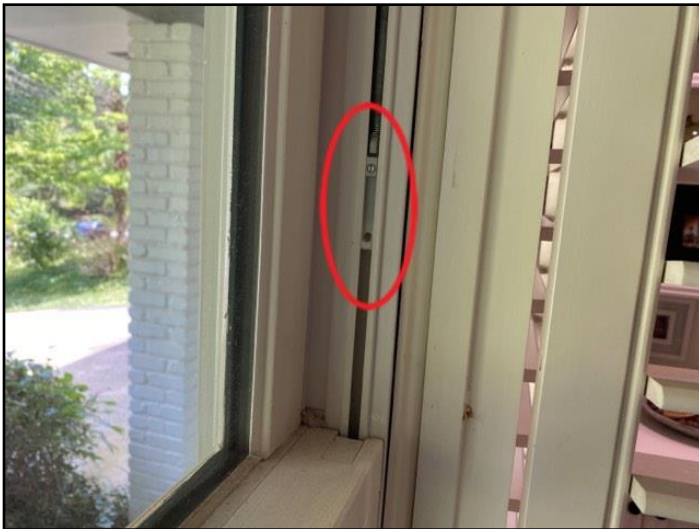
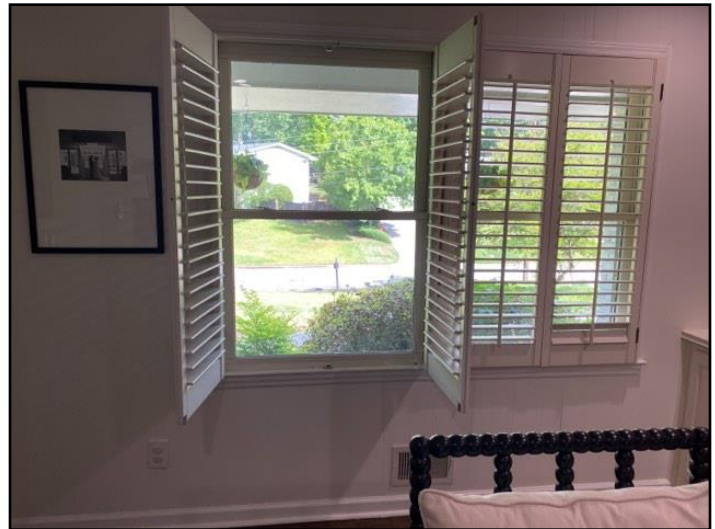
43. Condition: • Broken Sash Cords/Springs

79. Broken Sash Cords/Springs

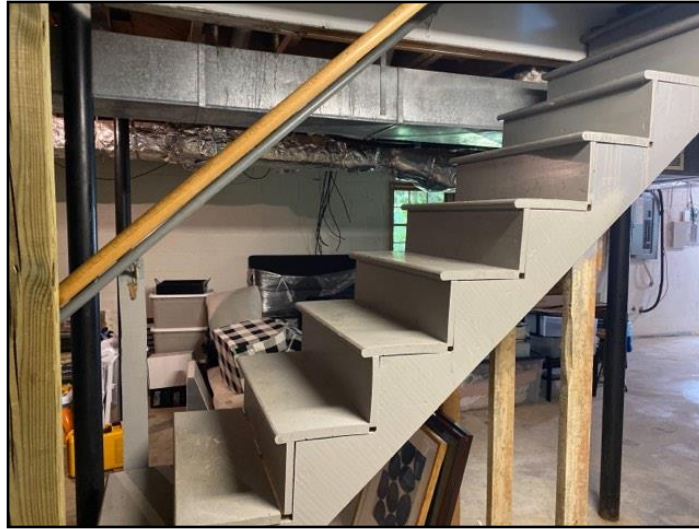
81. *Guardrail Missing*

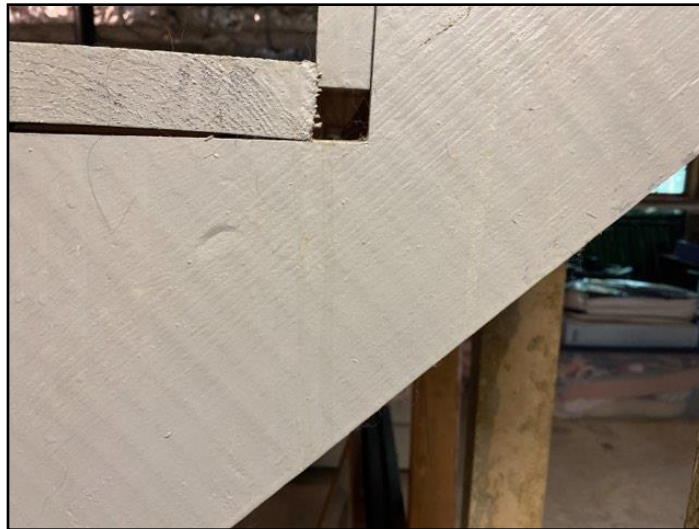
45. Condition: • Excessive notching of stringers

82. *Excessive notching of stringers*

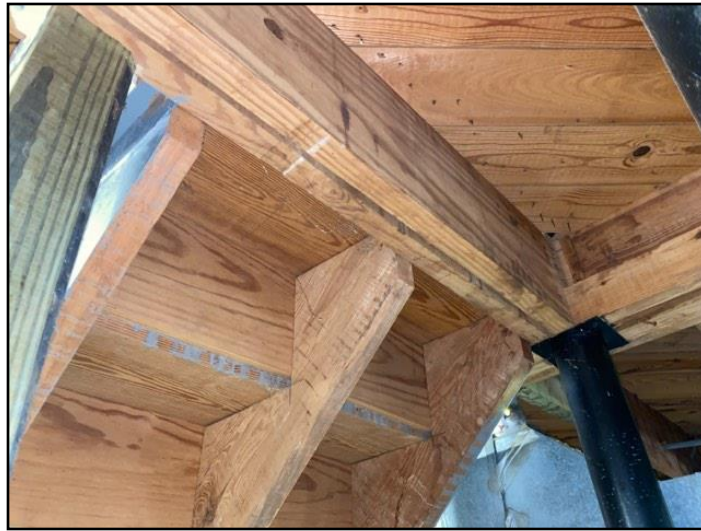
46. Condition: • Poorly supported

83. Poorly supported

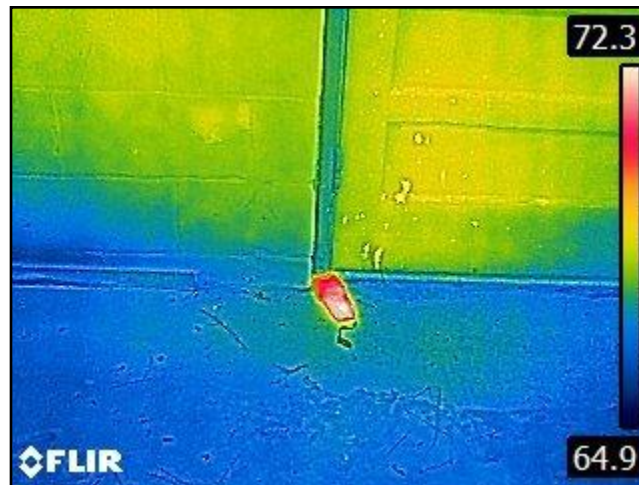
86. Dampness on floor or walls

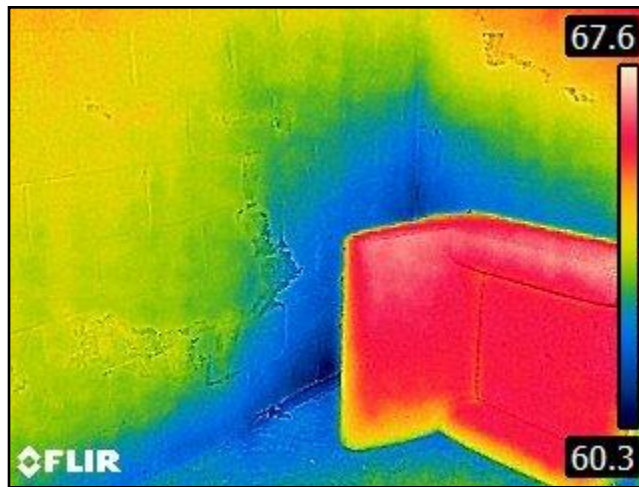
89. Dampness on floor or walls
