Your Inspection Report

2009 Happy Drive with THERMAL
Atlanta, GA

INSPECTION DATE:
Wednesday, May 10, 2023

PREPARED BY:
Mark Kinzie, Certified Thermal Inspector

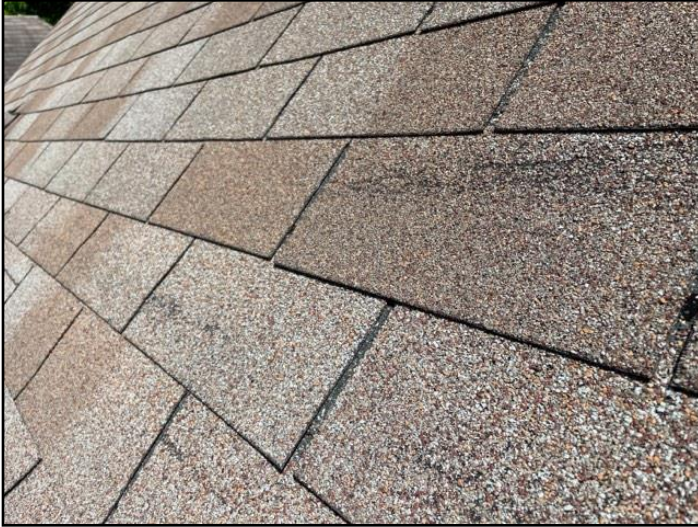
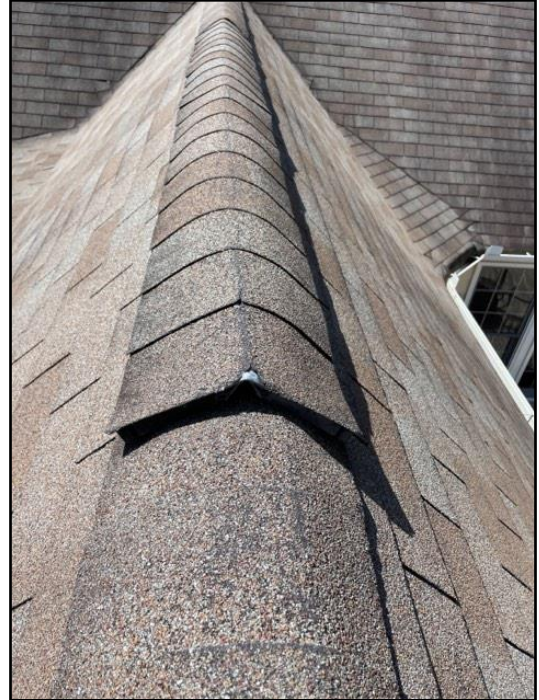
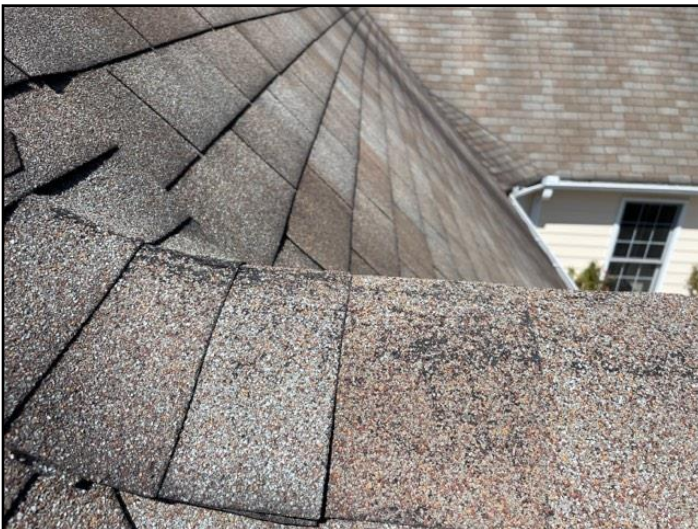
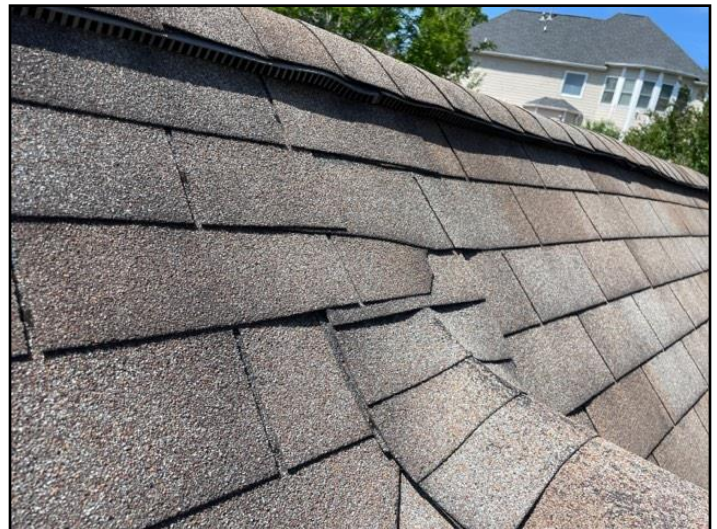
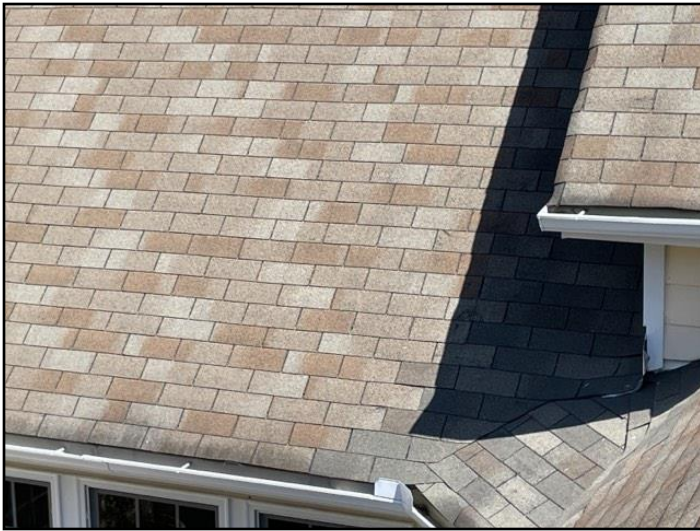
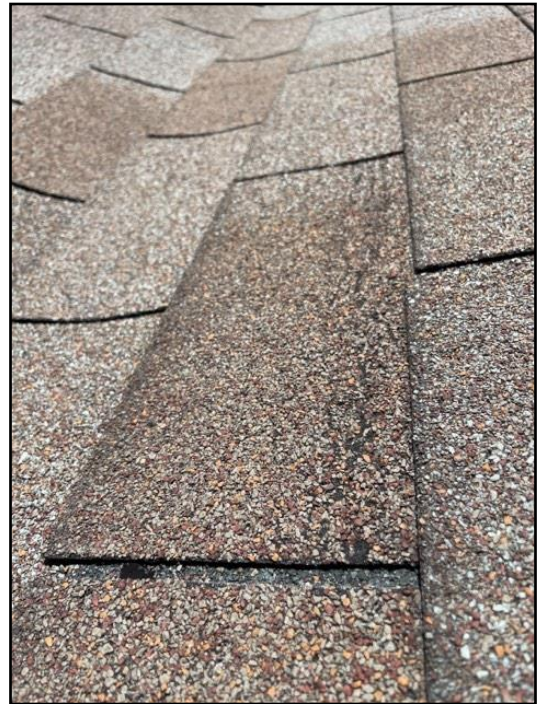
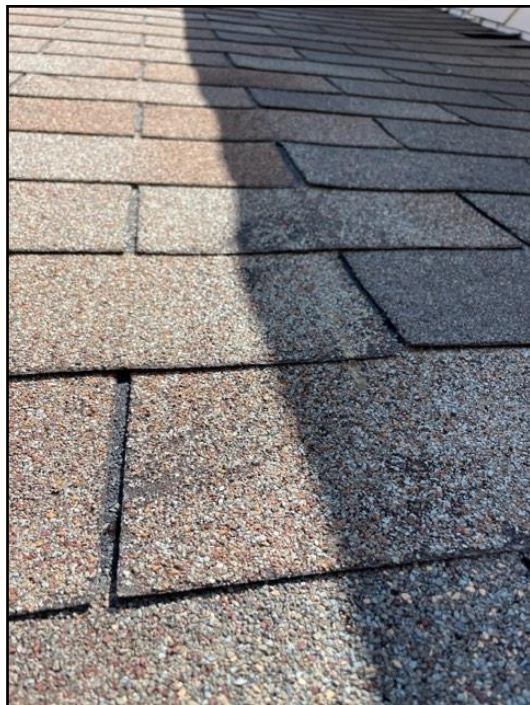
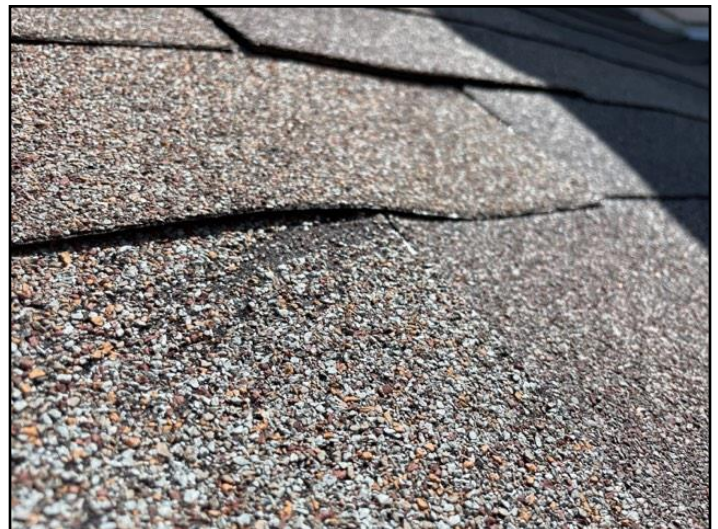
1. Condition: • Old, Worn Out

1. *Old, Worn Out*

2. *Old, Worn Out*

3. *Old, Worn Out*

4. *Old, Worn Out*

Time: As Soon As Possible

Cost: \$4.50 to \$7.50 per square foot depending on the quality and grade of shingles

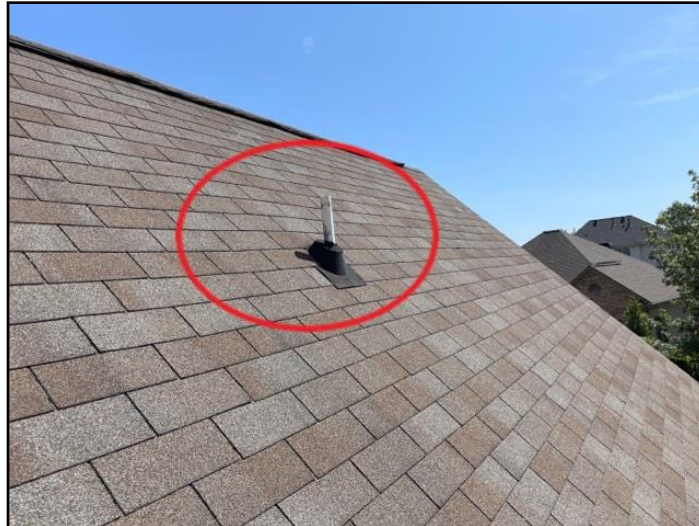
2. Condition: • Damage, loose, rusted or missing

9. Damage, loose, rusted or missing

Task: Repair or replace

Time: Immediate

Cost: \$300 - \$600 per location

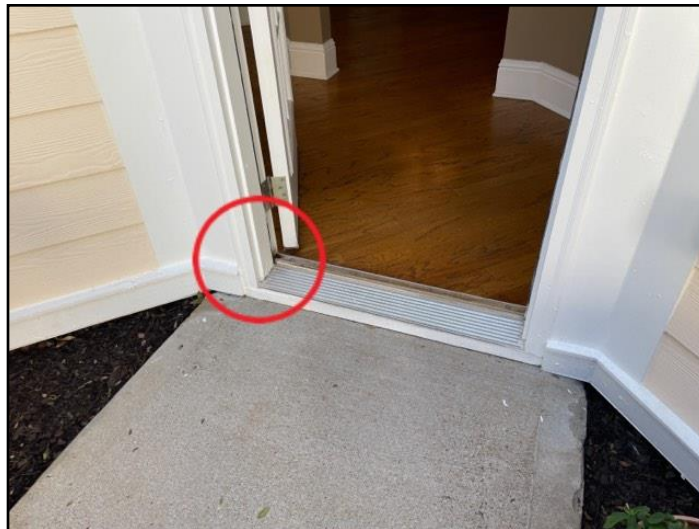
3. Condition: • Rot/Insect damage

14. *Rot/Insect damage*

Task: Repair or replace

Time: Immediate

Cost: \$150 - \$300 per location

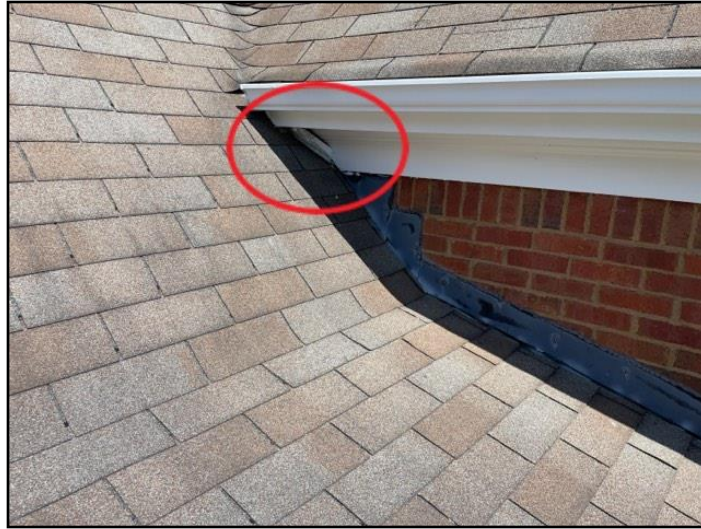
4. Condition: • Loose or missing pieces

15. Loose or missing pieces

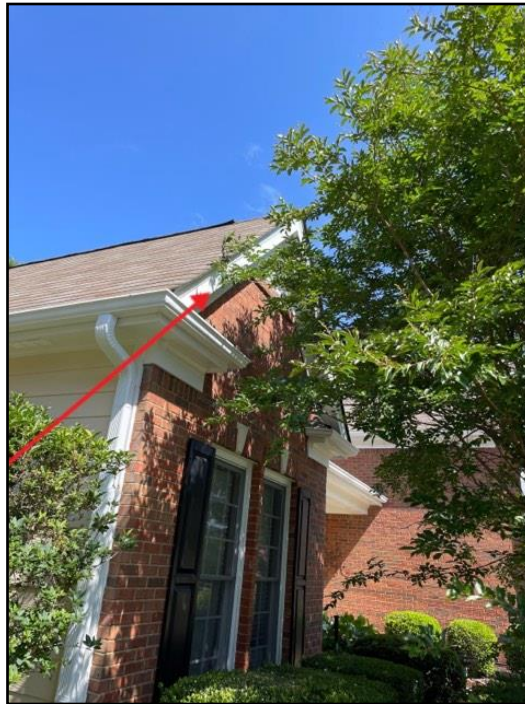
5. Condition: • Trees or Shrubs too close to building

16. Trees or Shrubs too close to building

Time: As Soon As Possible

Cost: Regular maintenance item

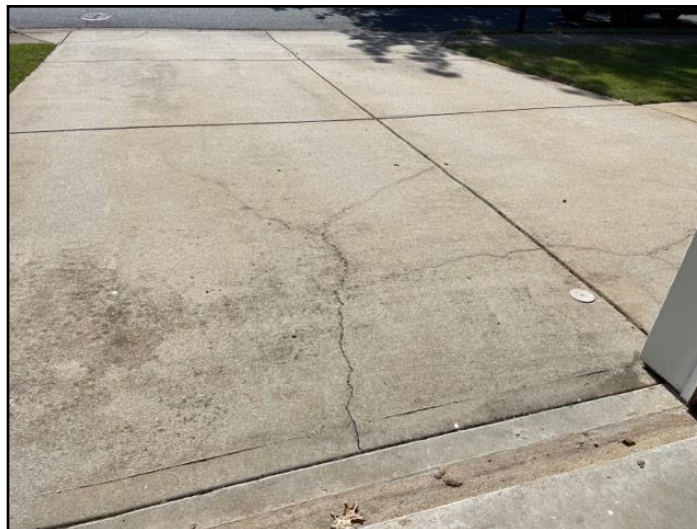
6. Condition: • Cracked or Damaged Surfaces

17. Cracked or Damaged Surfaces

Task: Repair As Needed

Time: Discretionary

Cost: \$5 to \$7 per square foot to pour concrete

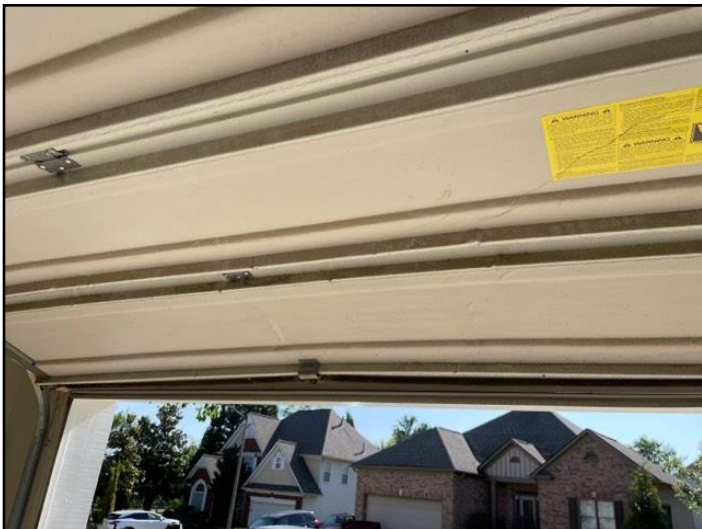
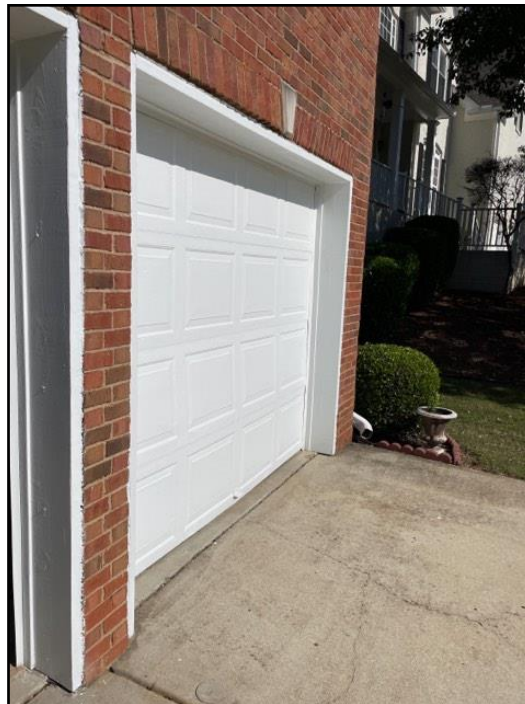
7. Condition: • Vehicle Door is Dented/Damaged
This is more a cosmetic issue as door functions properly.

18. *Vehicle Door is Dented/Damaged*

19. *Vehicle Door is Dented/Damaged*

Task: Repair or replace

Time: Discretionary

Cost: Depends on the preferred remedy of repair

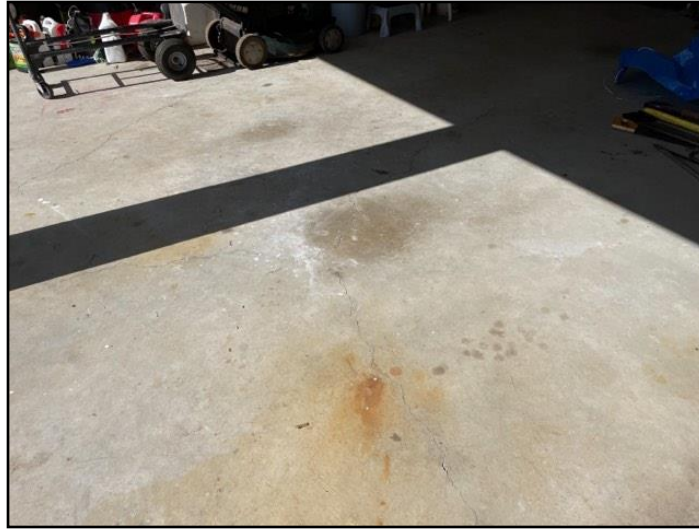
8. Condition: • Cracks in Floor

Typical shrinkage cracking.

20. Cracks in Floor

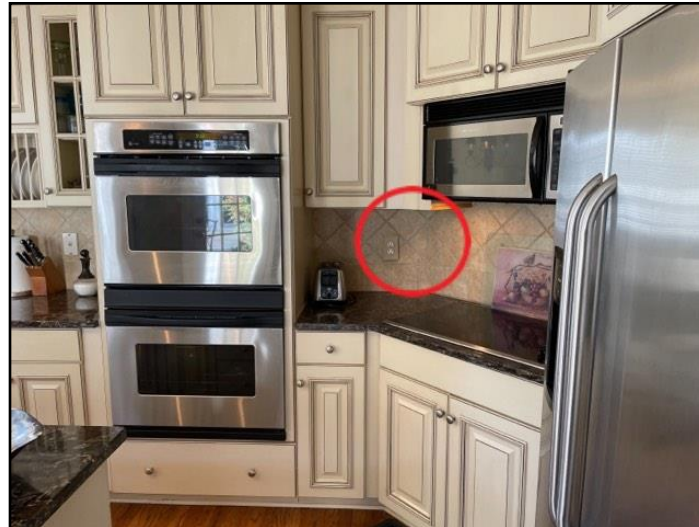
10. Condition: • Loose Receptacles (Outlets) noted

23. Loose Receptacles (Outlets) noted

Time: Immediate

Cost: Minor

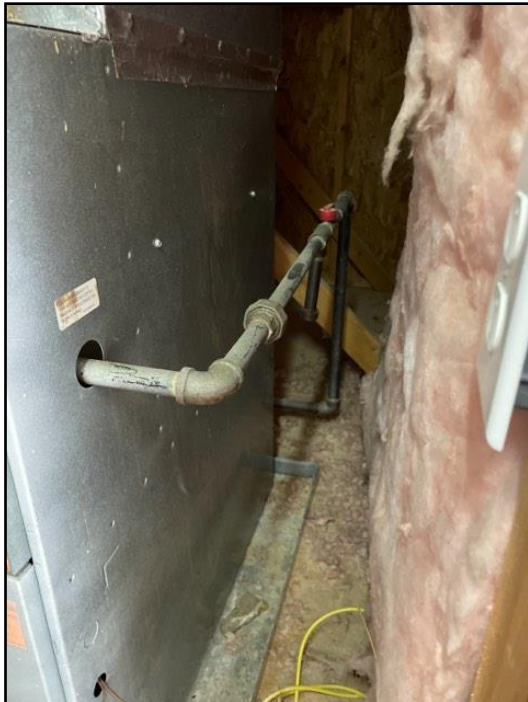
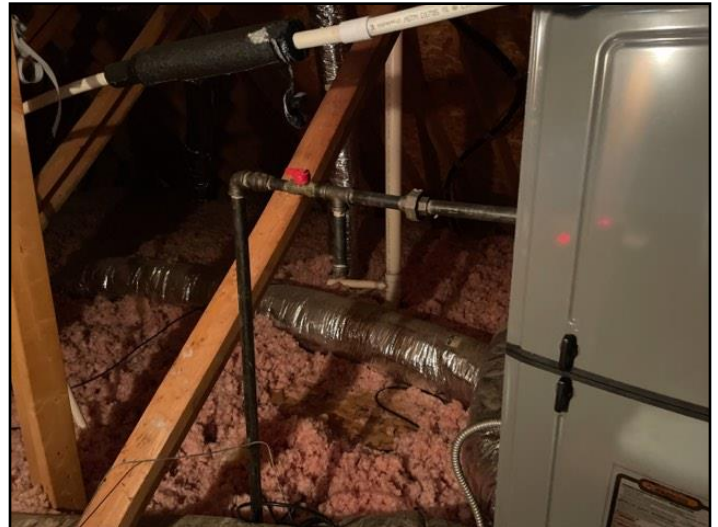
27. No drip leg (sediment trap, dirt pocket)

28. No drip leg (sediment trap, dirt pocket)

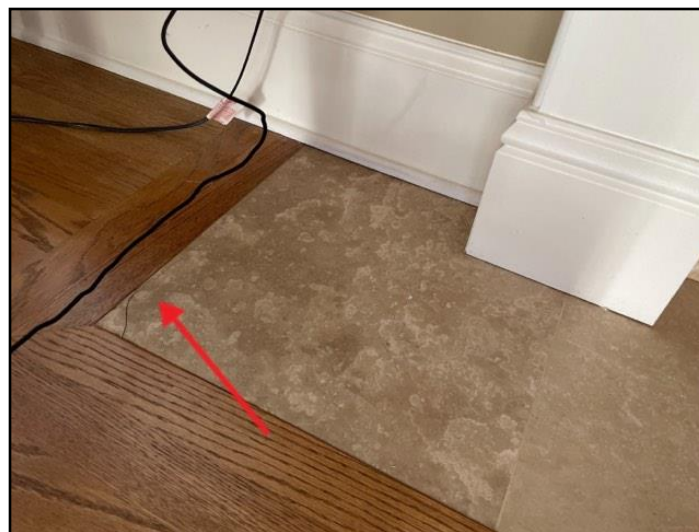
29. Gaps or cracks

Time: Discretionary

Cost: Minor

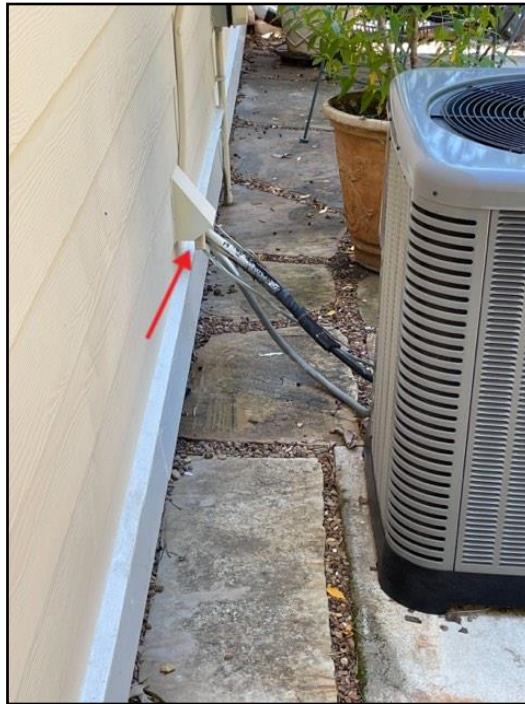
38. *Improper Discharge Point*

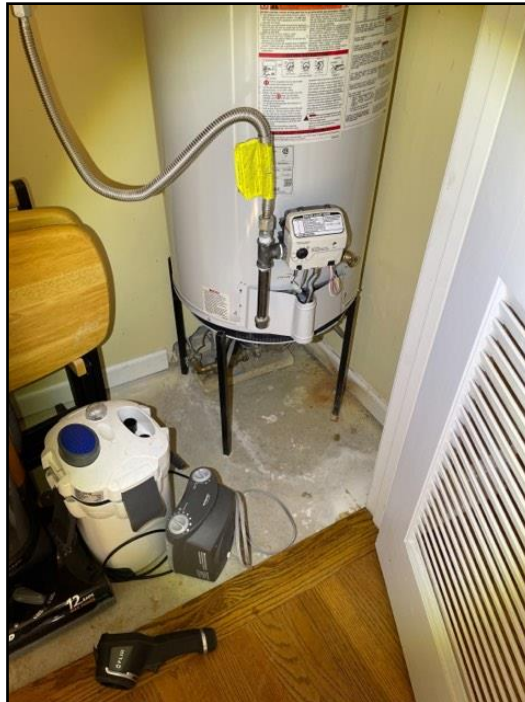
43. Drain pan missing

Time: Immediate

Cost: Minor

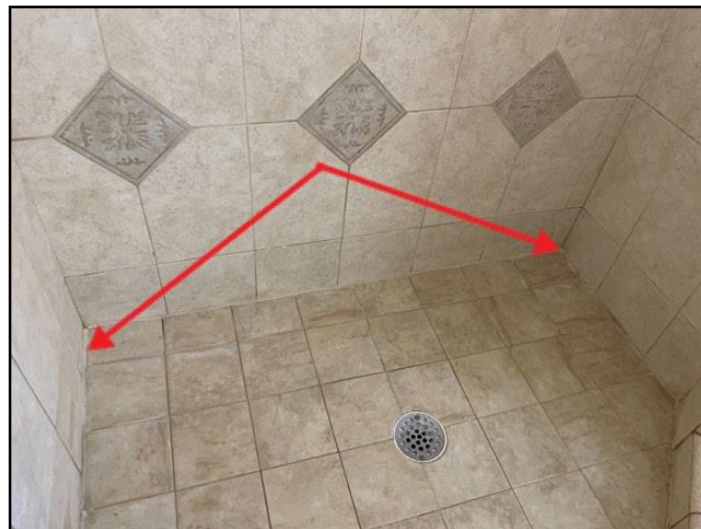
45. *Caulking/Grout missing and or deteriorated...*

Time: As Soon As Possible

Cost: Regular maintenance item

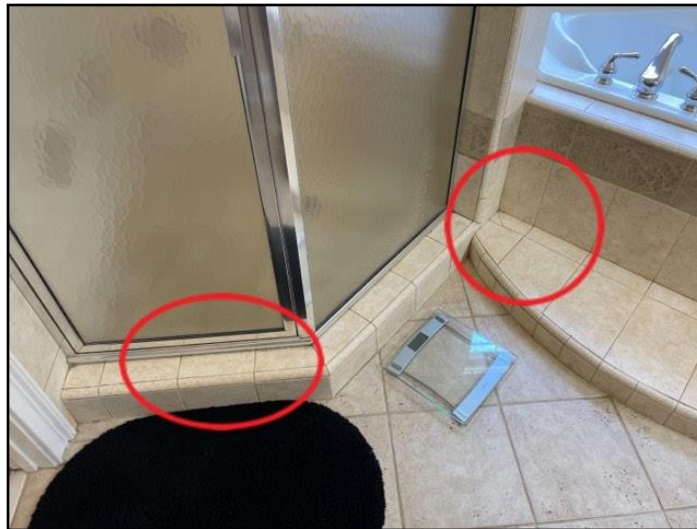
46. Loose/cracked tile

Time: As Soon As Possible

Cost: Depends on the level of work needed

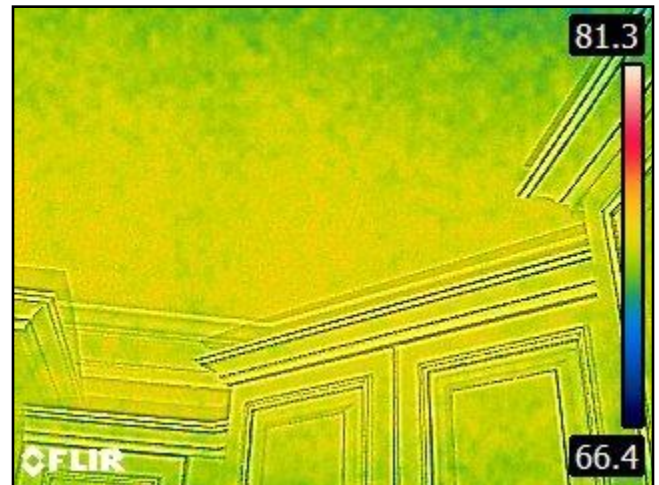
53. Patched/Painted Areas

28. Condition: • Patched/Painted Areas

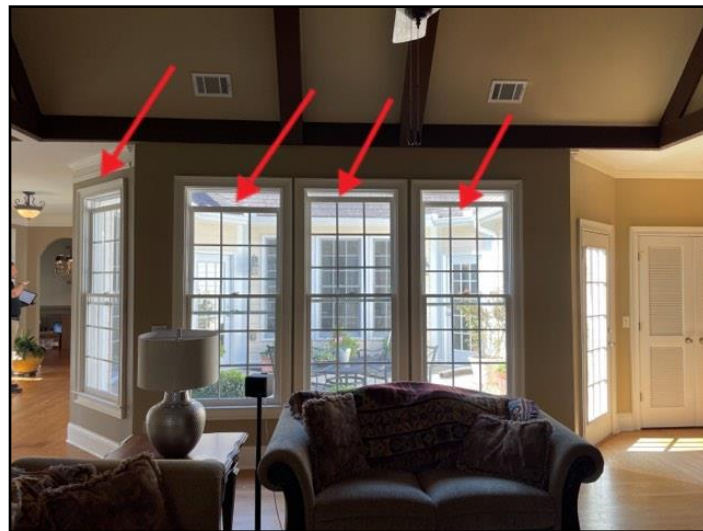
58. Sash Won't Stay Open or Closed

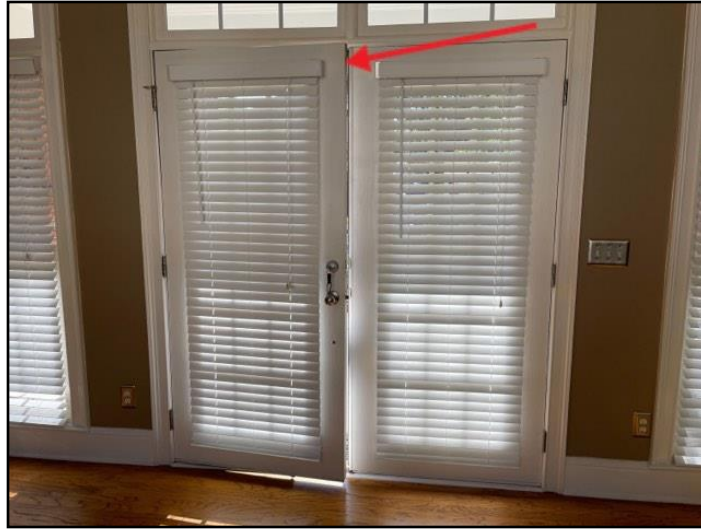
32. Condition: • Poor Fit

59. Poor Fit

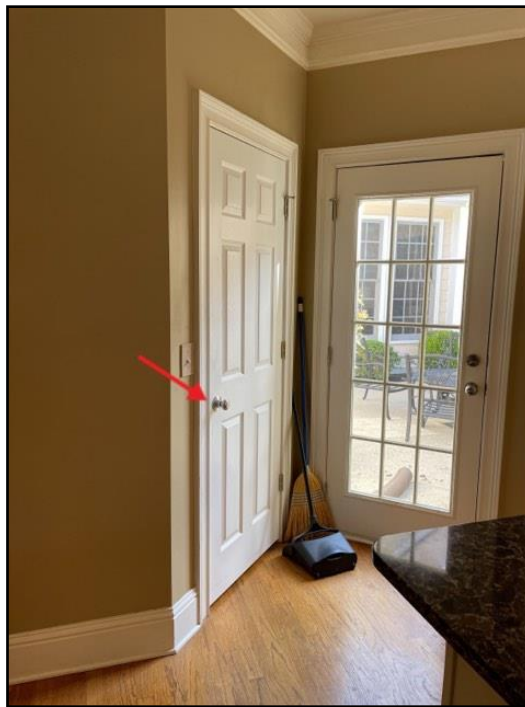
33. Condition: • [Does Not Latch Properly - Click for DIY Video](#)

60. Does Not Latch Properly - Click for DIY Video

Time: Discretionary

Cost: Minor

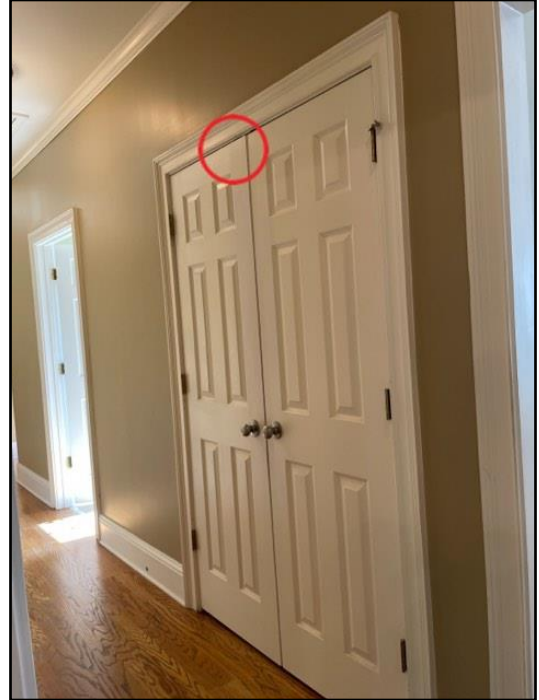
34. Condition: • [Does Not Latch Properly - Click for DIY Video](#)

62. Does Not Latch Properly - Click for DIY Video

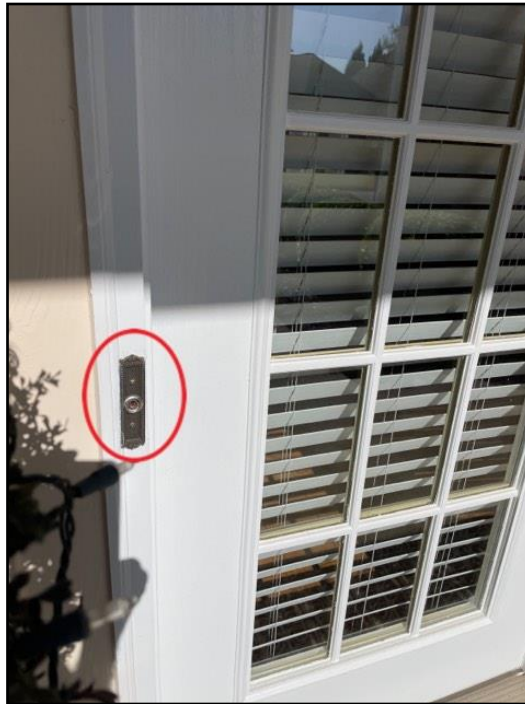
64. Button damaged

Time: As Soon As Possible

Cost: Minor
