# Your Inspection Report

## Pre-Drywall Sample Report Atlanta, GA

Pre Drywall Sample, Atlanta, GA    November 25, 2015

Report No. 15316

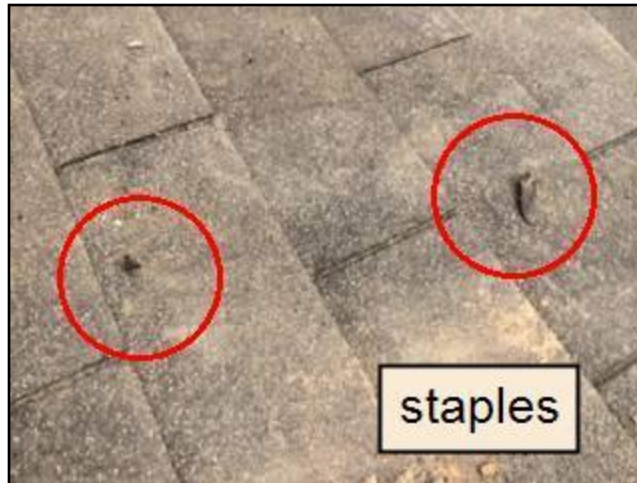
1. Damage

#### 1. Condition: • [Damage](#)

Shingles have been damaged by staples.

**Task:** Repair / Seal

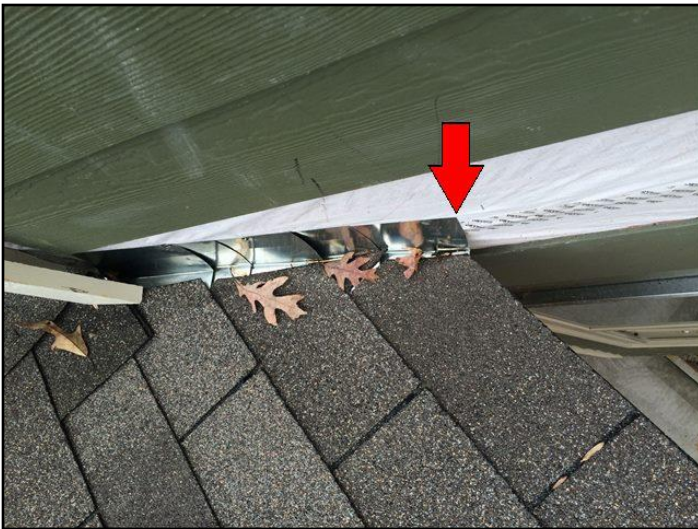
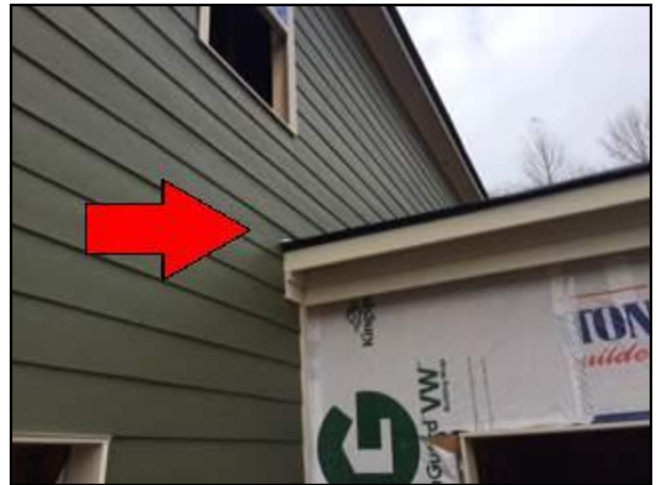
#### 2. Condition: • [Flashings missing](#)

Missing kickout flashing at rear exterior patio roof structure and front right garage. R905.2.8.3

**Task:** Provide

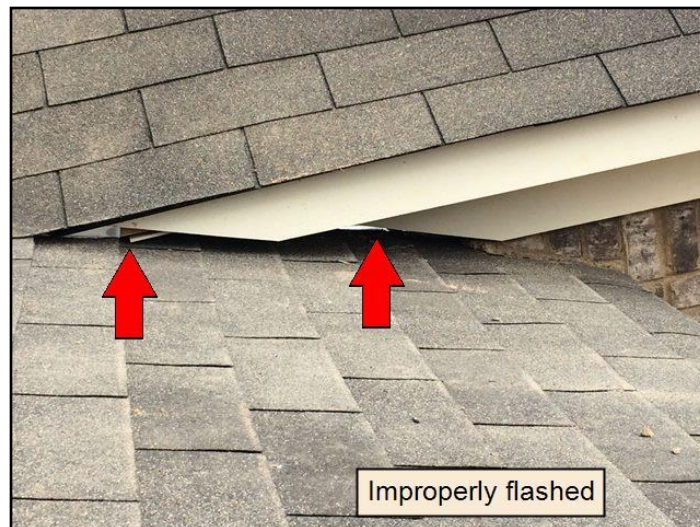
4. Flashings incomplete or ineffective

#### 3. Condition: • [Flashings incomplete or ineffective](#)

Improper flashing at front fascia / roof connection. Exposed untreated material. Flashing directs flow behind trim.

**Task:** Correct

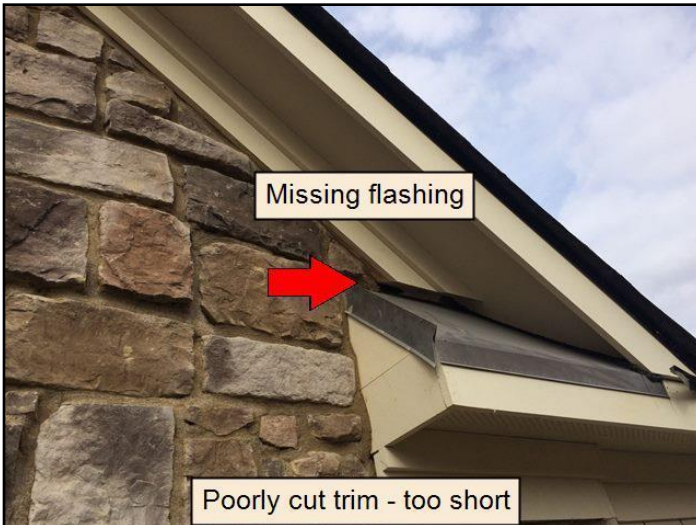
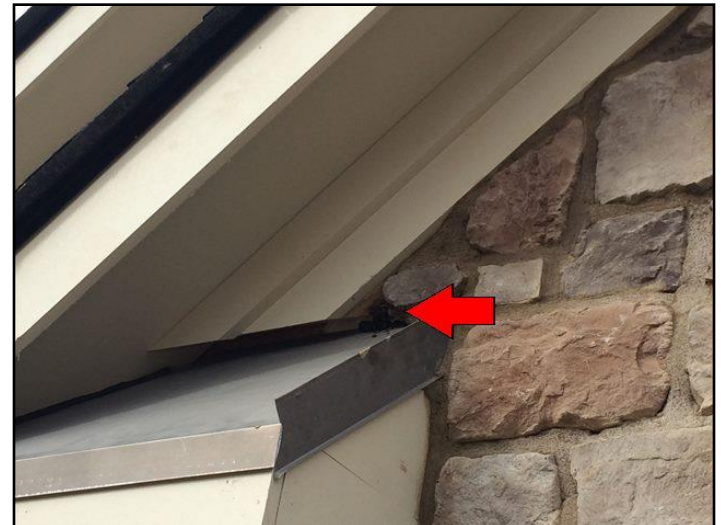
#### 4. Condition: • [Flashings incomplete or ineffective](#)

Trim has been cut too short at front exterior. Missing flashing behind trim.

**Task:** Correct

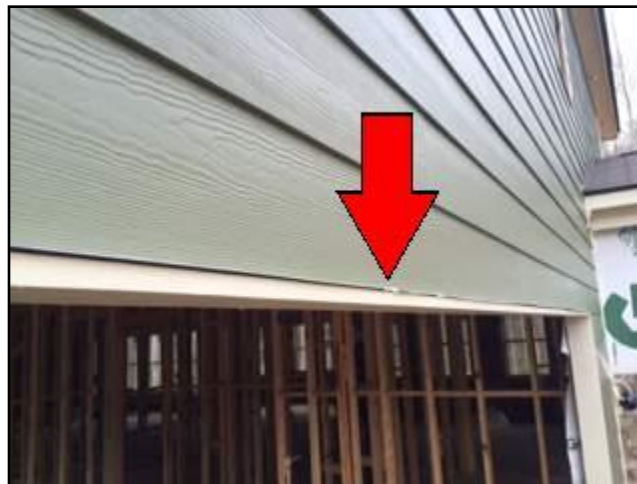
7. *Flashings incomplete or ineffective*

**5. Condition:** • [Flashings incomplete or ineffective](#)

Improper flashing at garage portal exterior

**Task:** Correct

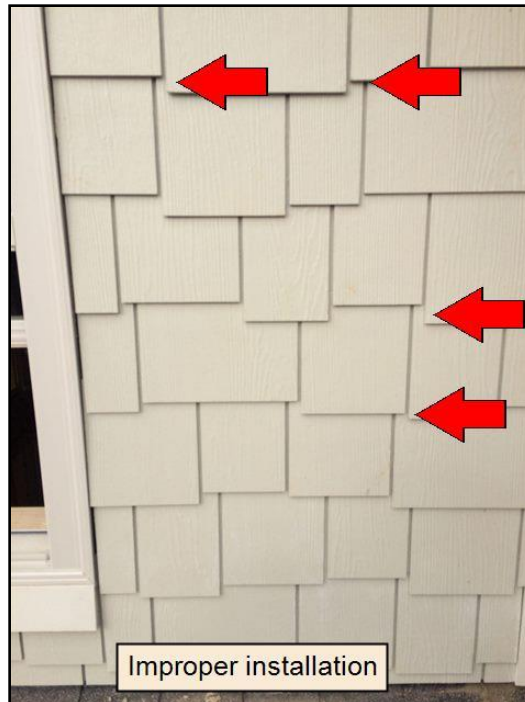
8.

**6. Condition:** • Improper installation of hardishingle siding. Manufacture installation instructions require a lap of 1-1/2" between joints and successive course. See manufacture installation instructions for more details/ illustrations.

**Task:** Correct

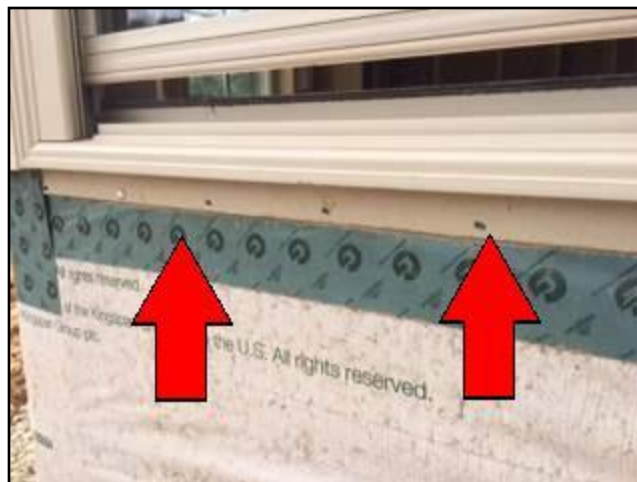
9.

**7. Condition:** • Improper installation of window at front exposed window flange. Manufacture provided fastener holes on window flange not being used as suggested. Recommend following manufacture installation instructions. Cannot determine if all windows are the same as there are only a limited number of windows where this is visible.

**Task:** Correct

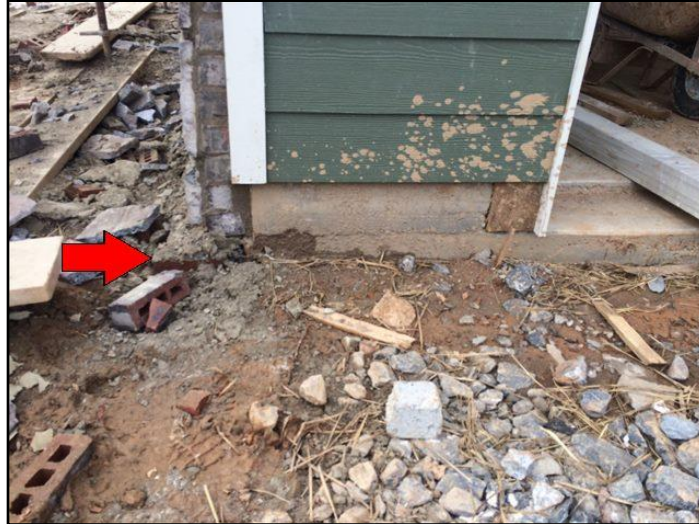
10.

**8. Condition:** • Brick ledge for front exterior brick wall is a layer of brick laying flat on grade. This is typically poured concrete foundation material.

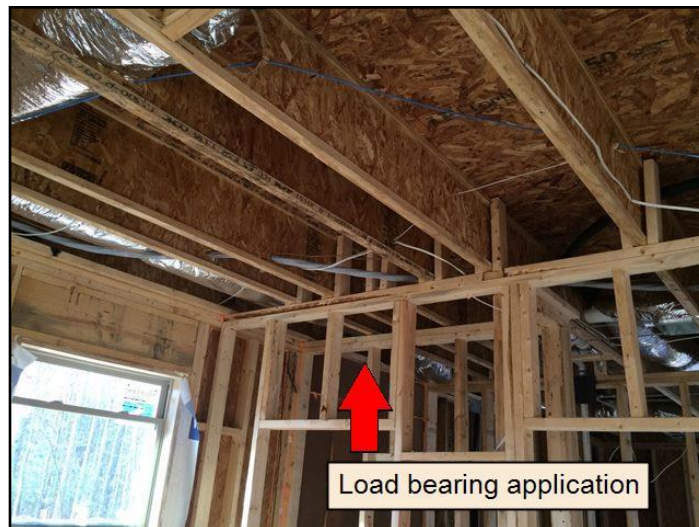
11.

**9. Condition:** • Load bearing support missing at I joist connection in front left bedroom / bathroom area.

**Task:** Correct

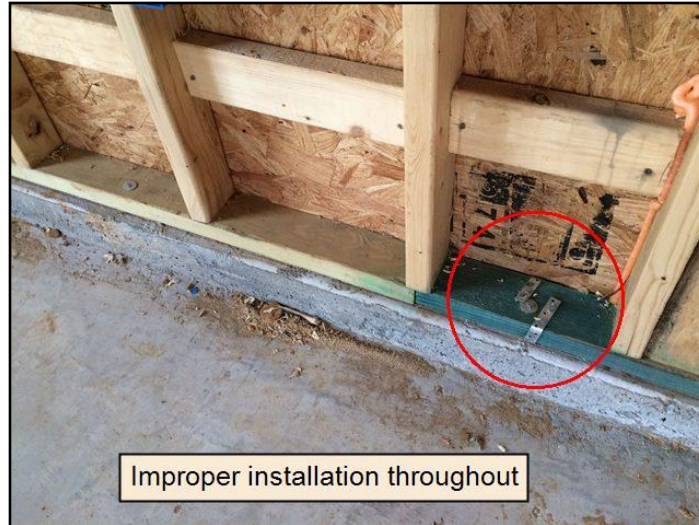
12.

**10. Condition:** • Improper installation of MAB mudsill anchor. Recommend installing according to manufacture

instructions.

**Task:** Correct

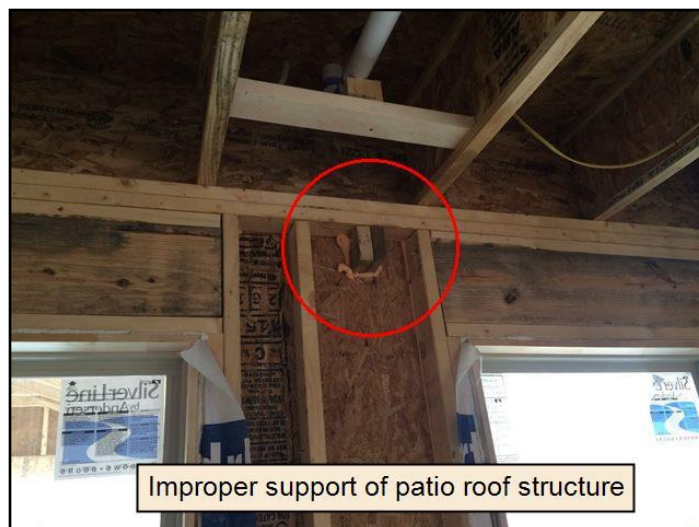
13.

**11. Condition:** • Rear exterior deck roof structure is not properly supported. Structure is being supported by OSB sheathing which is not a viable structural support.

**Task:** Correct

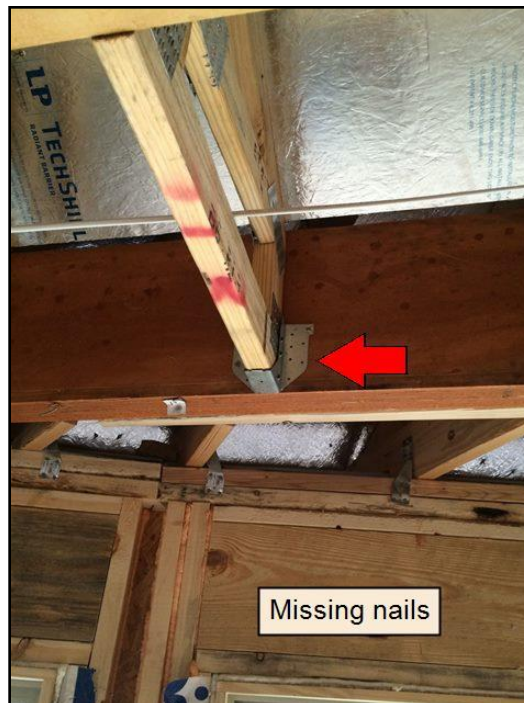
14. Poor end bearing, joist hanger connections

**12. Condition:** • [Poor end bearing, joist hanger connections](#)

Joist hangers missing nails. All nail holes must be used.

**Task:** Correct

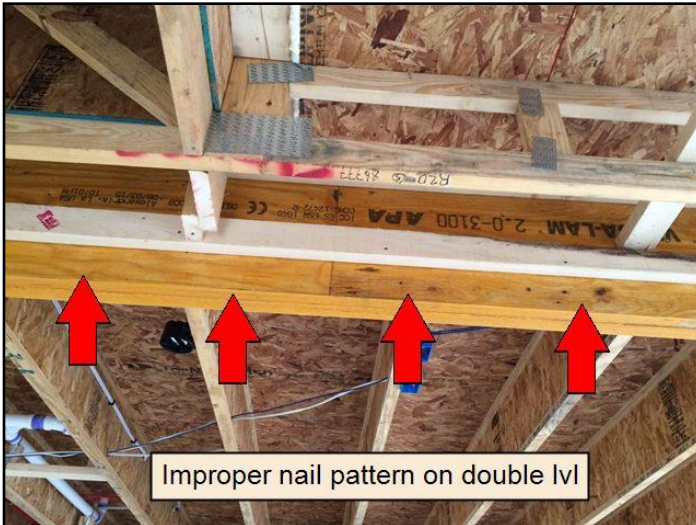
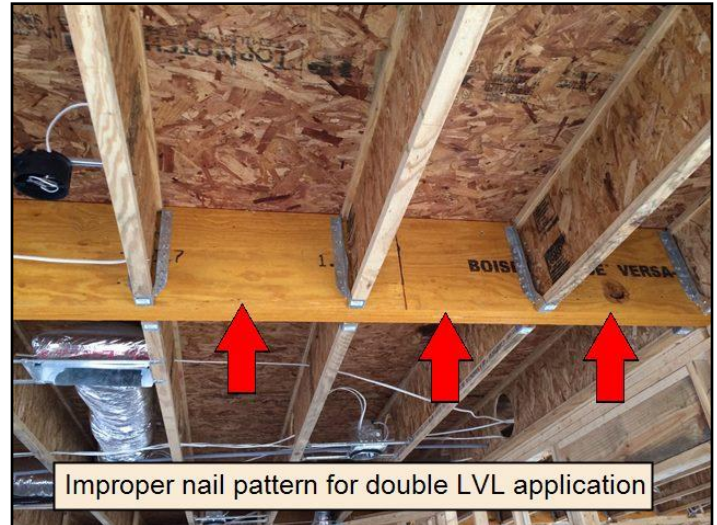
**13. Condition:** • Multiple Doubled LVL beams do not meet the minimum manufacture recommended fastening requirements.

**Task:** Correct

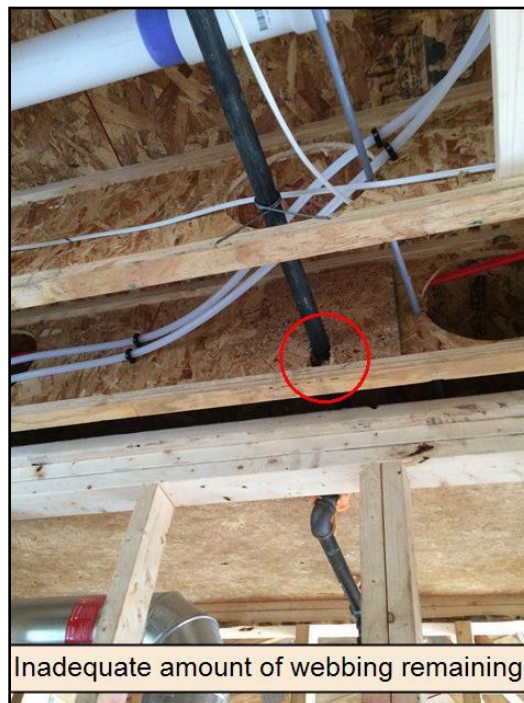
17. Notches or holes

## 14. Condition: • [Notches or holes](#)

According to manufacture recommendations, Holes in I joist webbing should be maintained with a minimum distance to the flange of 1/8". Hole is overcut to where there is not 1/8" of webbing between the hole and the flange. Hole cut for gas line

**Task:** Correct

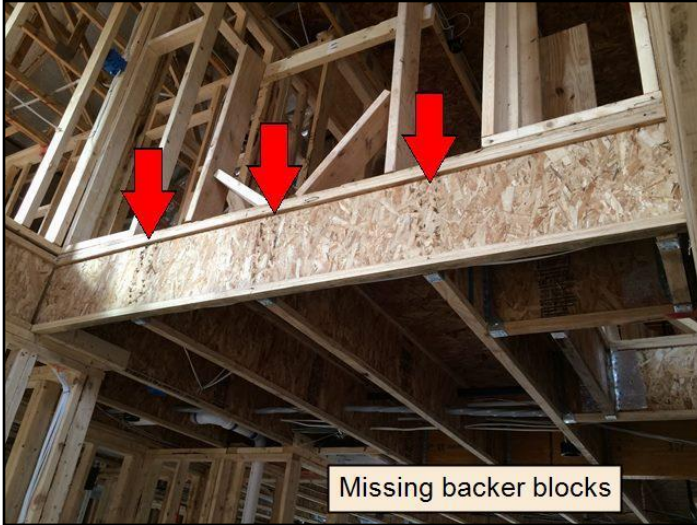
18. Poor end bearing, joist hanger connections

**15. Condition:** • [Poor end bearing, joist hanger connections](#)

Backer blocks required on both sides of web per hanger manufacturer recommendations.

**Task:** Correct

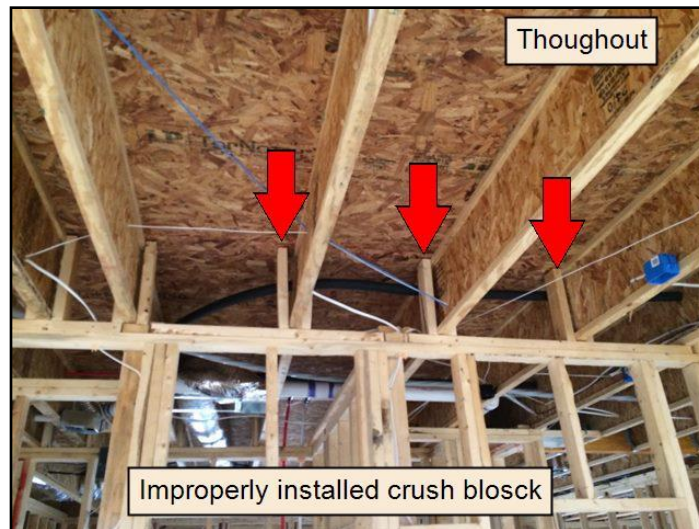
21. Ineffective blocking, bracing or bridging

**16. Condition:** • [Ineffective blocking, bracing or bridging](#)

Squash blocks are loose and ineffective throughout. They should be installed according to I joist manufacturer recommendations-

Squash blocks should be 1/16" longer than the size of the I joist when installed at interior bearing.

**Task:** Correct

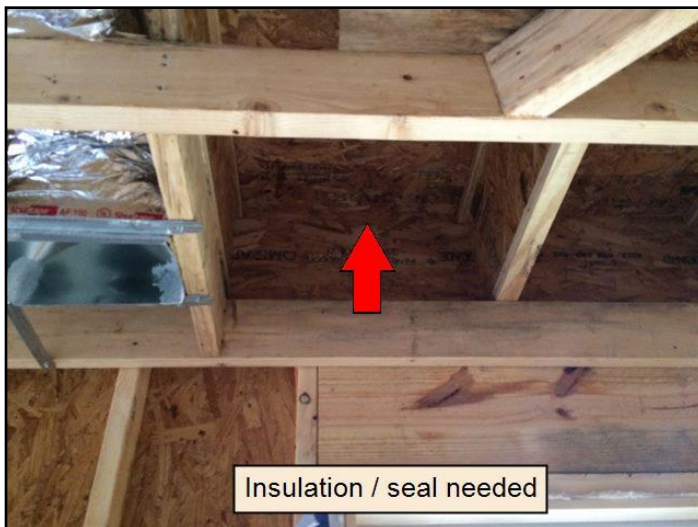
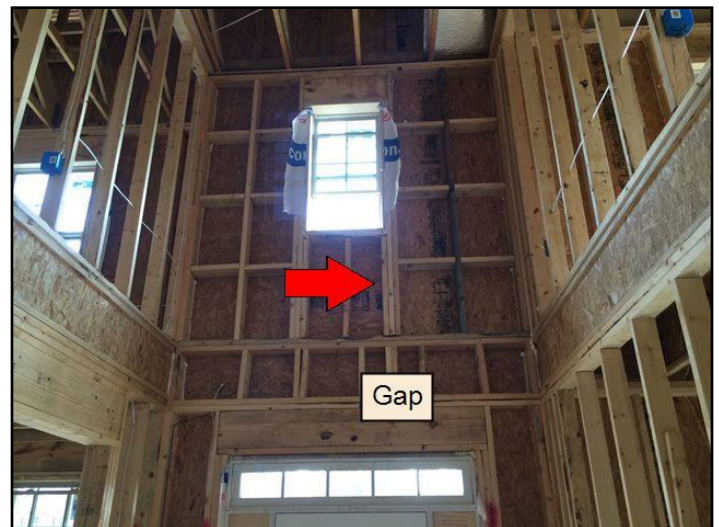
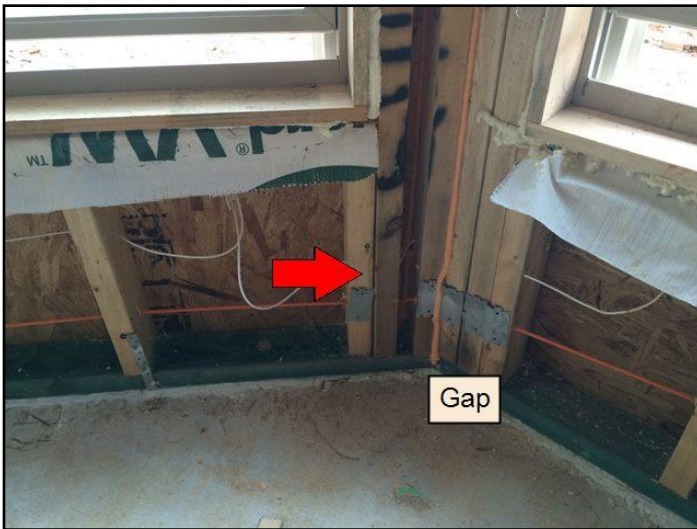
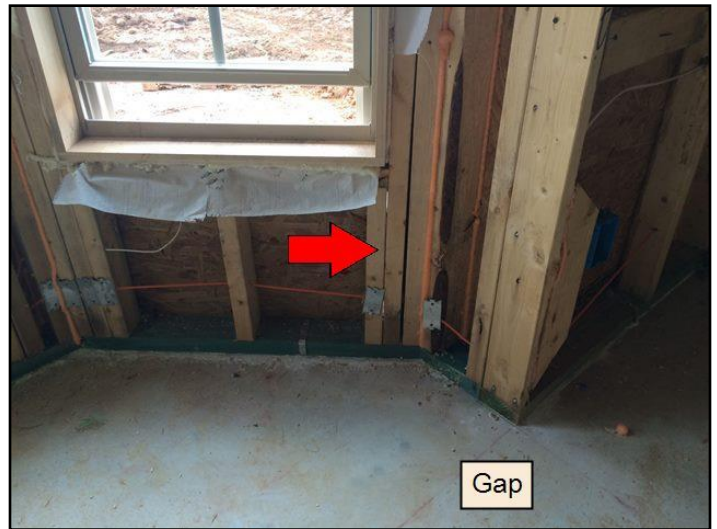
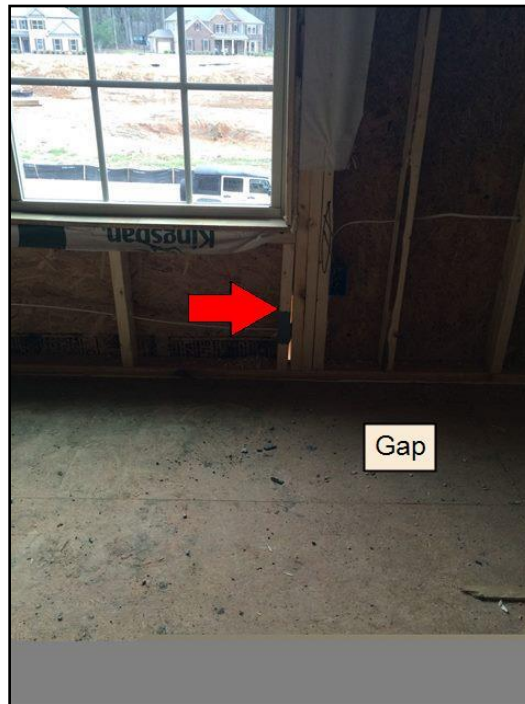
17. **Condition:** • There are multiple gaps in the framework and sheathing at the exterior wall that should be sealed.

**Task:** Seal

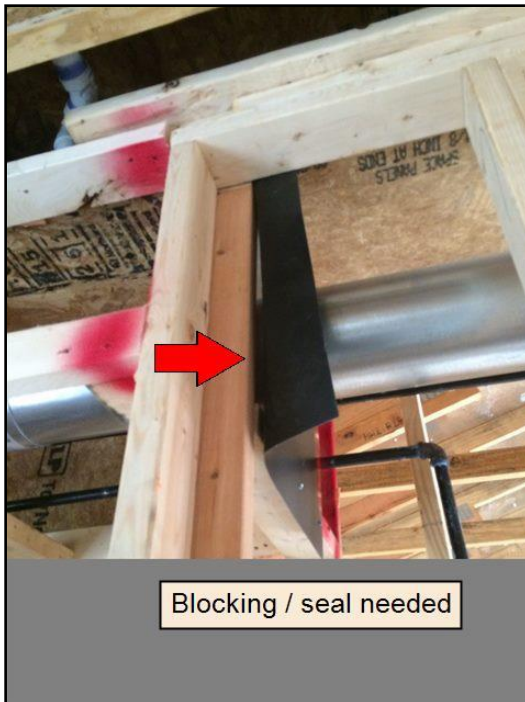
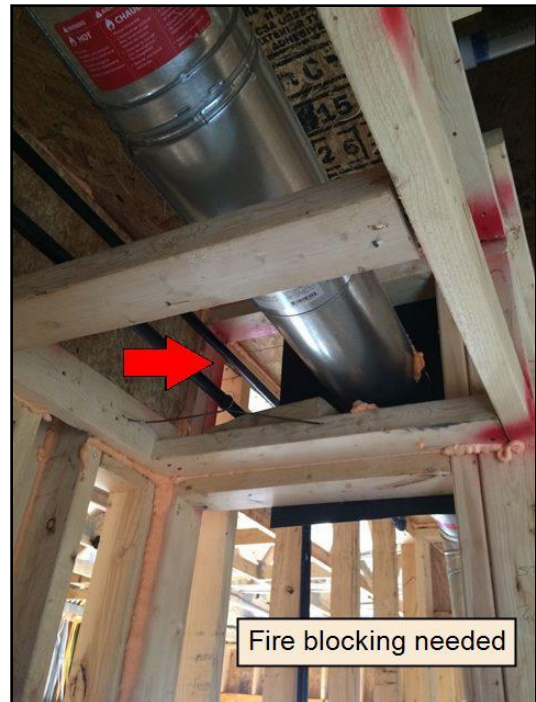
**18. Condition:** • [Firestopping missing](#)

**Task:** Correct

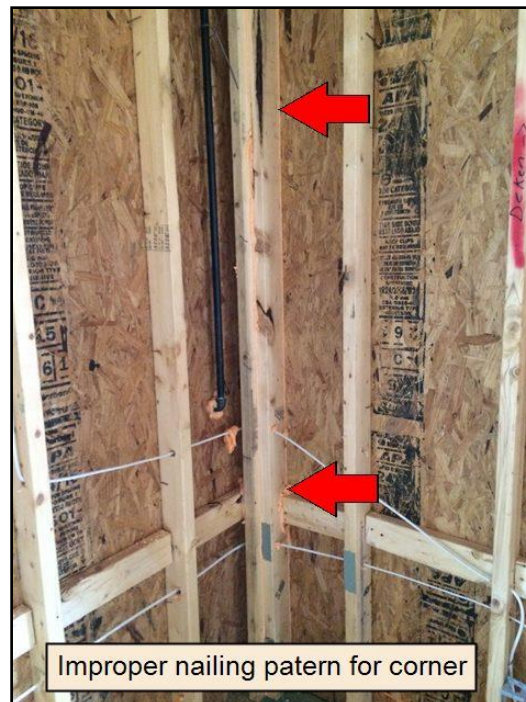
29. Poor nailing

19. Condition: • [Poor nailing](#)

Improper nailing of abutting studs at intersecting wall corners. 12" O.C. required. Table R602.3

Task: Correct

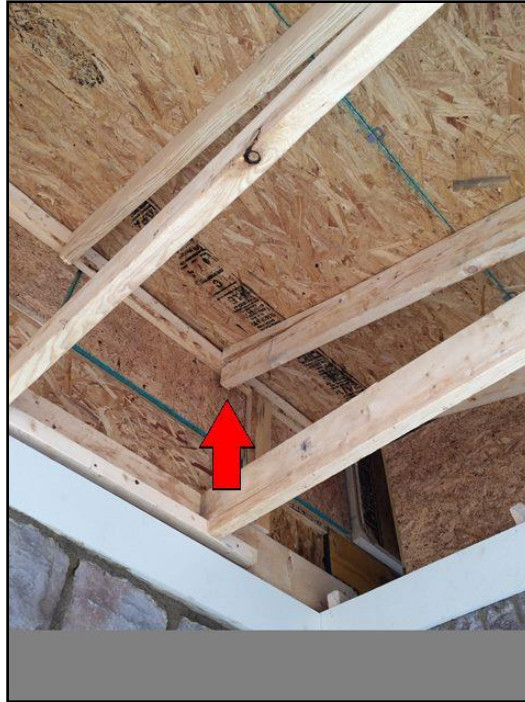
### **30. Split**

### **20. Condition:** • [Split](#)

Roof joist split at patio roof structure. Improper plumb cut of rafters to connection surface results in damage.

**Task:** Correct Repair

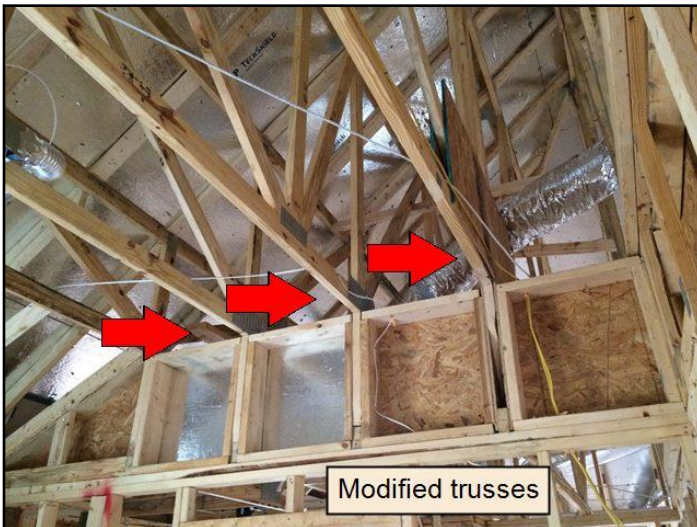
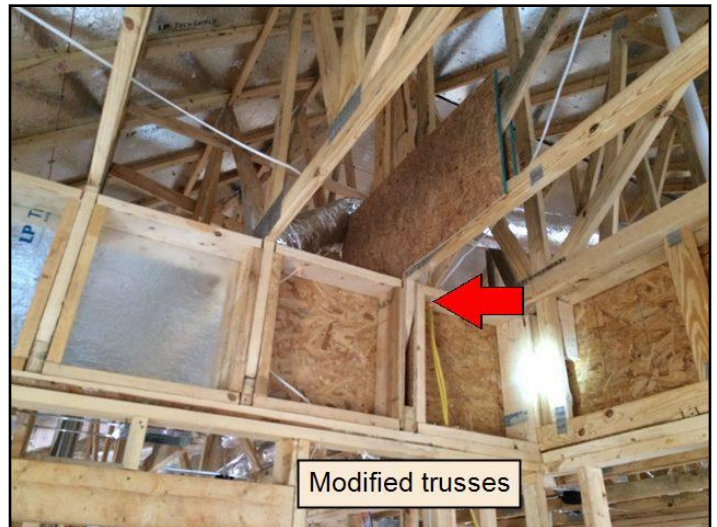
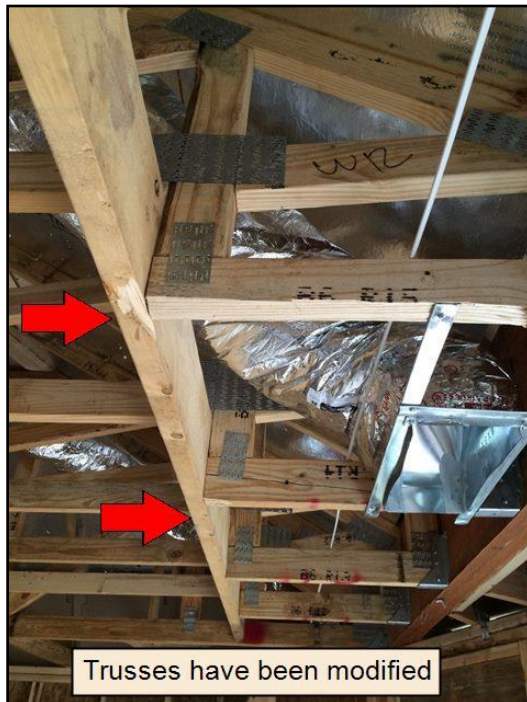
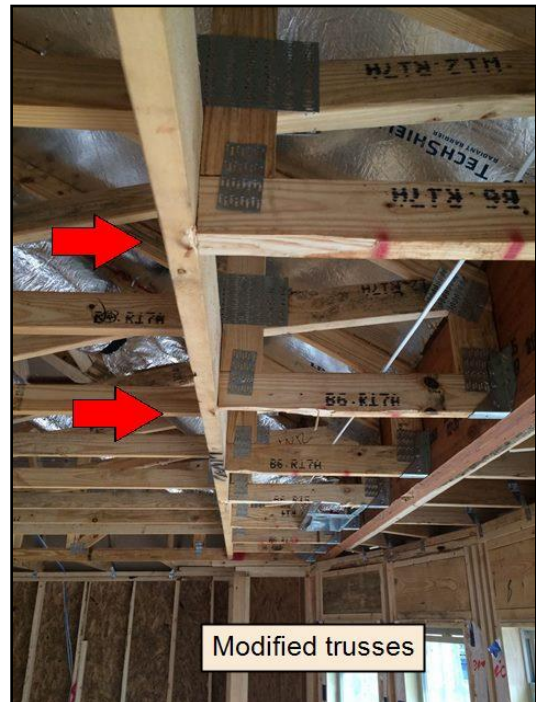
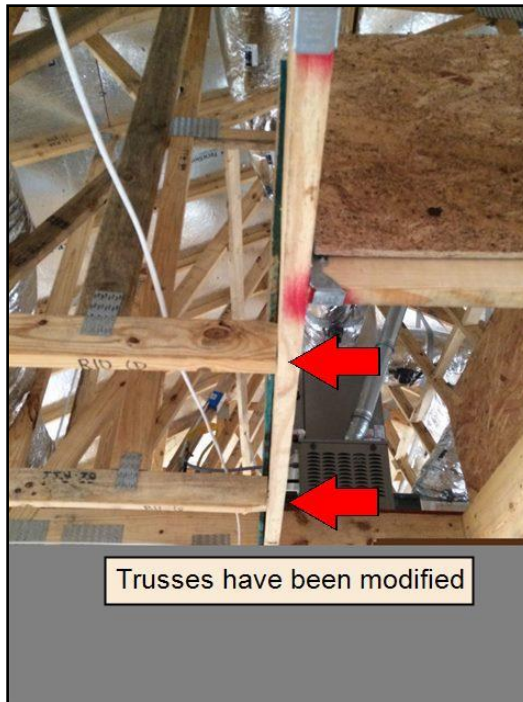
### **21. Condition:** • [Modified or spliced](#)

Multiple trusses have been altered to fit. A letter from structural engineer approving application is necessary. Master bathroom, attic access location, and living room area.

R503.11.3 Alterations to trusses. Truss members and components shall not be cut, notched, spliced or otherwise altered in any way without the approval of a registered design professional.

**Task:** Correct

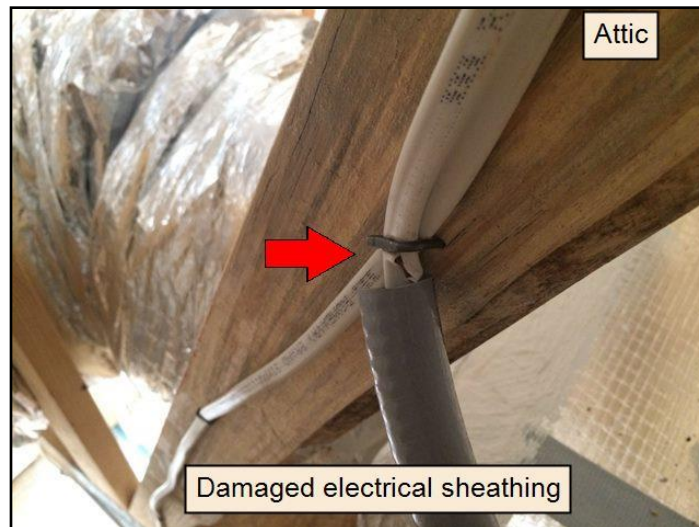
36. Damage

**22. Condition:** • [Damage](#)

**Task:** Repair

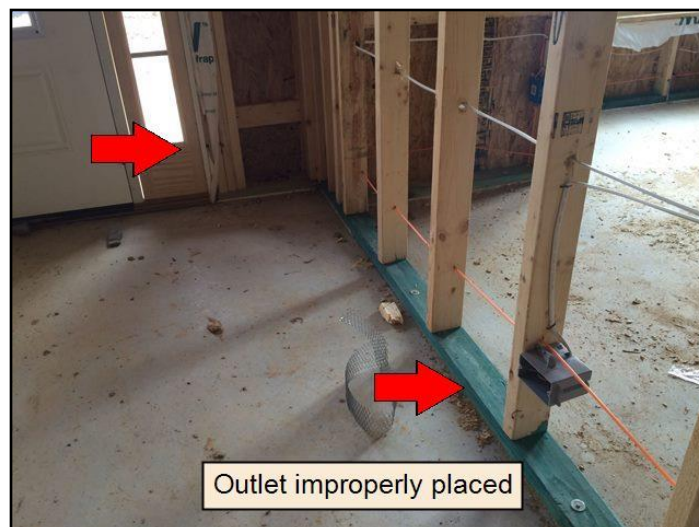
37.

**23. Condition:** • Improperly spaced outlet at front foyer. Receptacles shall be installed so that no point measured horizontally on the floor line in any wall space is more than 6 ft from a receptacle outlet. E3901.2.2

**Task:** Correct

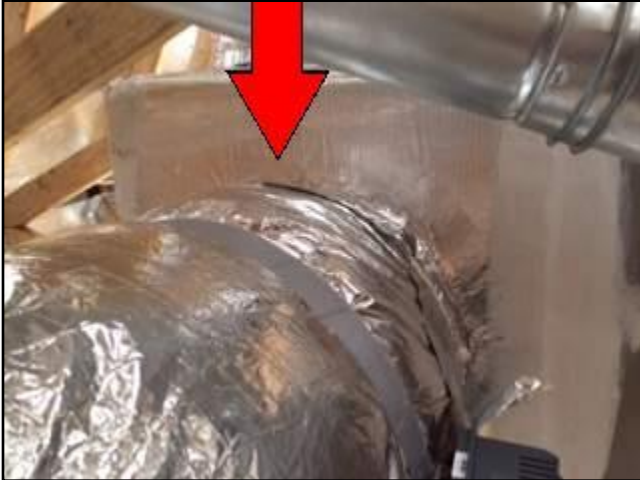
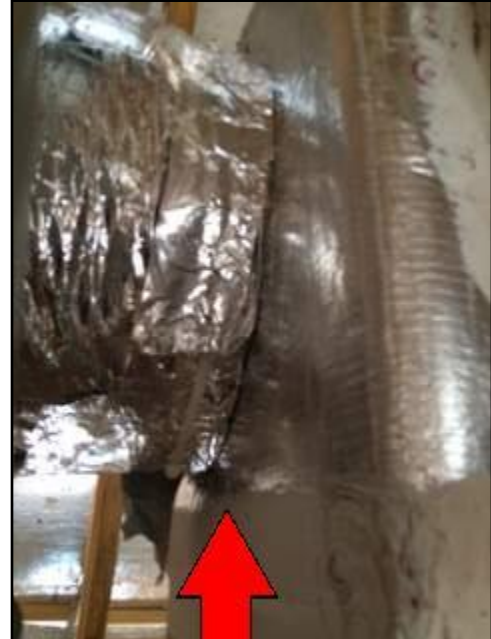
**24. Condition:** • Duct mastic missing at plenum in attic.

**Task:** Provide

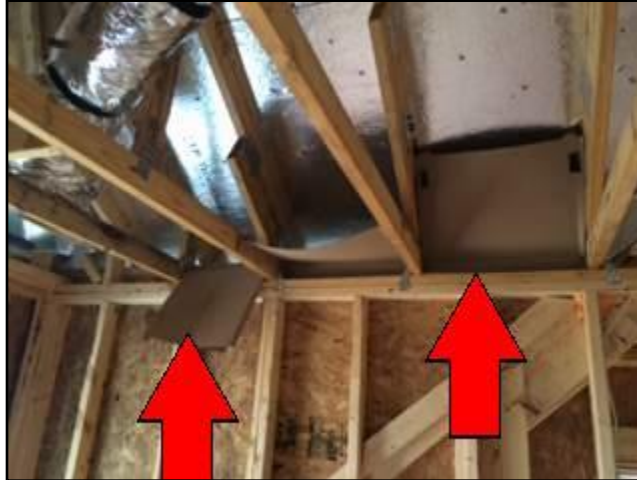
40.

**25. Condition:** • Baffles have collapsed at interior soffit opening.

**Task:** Correct

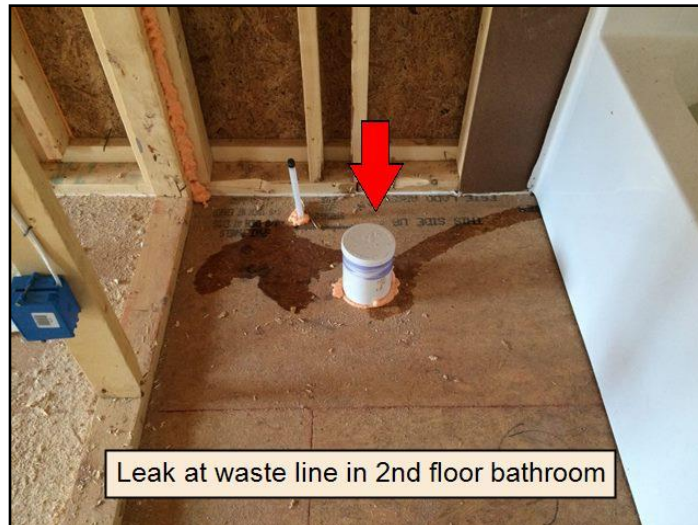
41. Leak

26. Condition: • [Leak](#)

Task: Repair

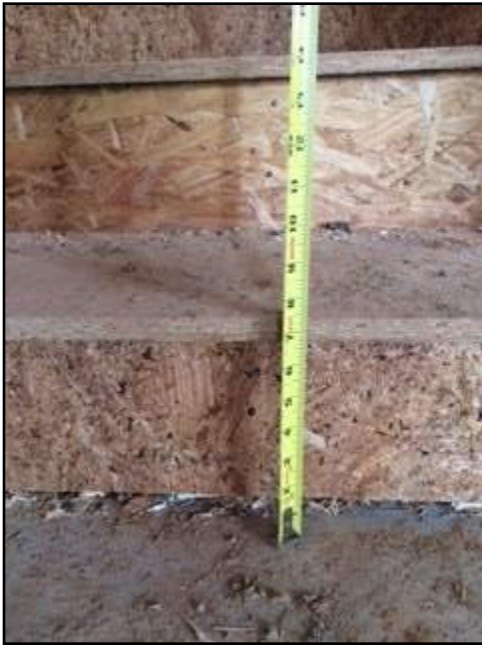
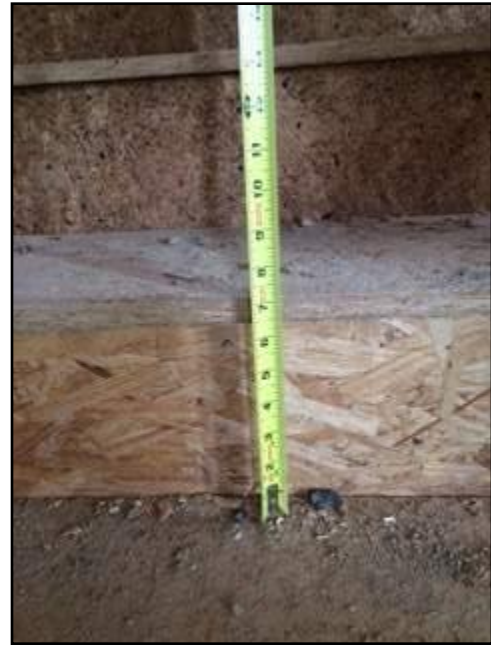
#### 27. Condition: • [Rise or run not uniform](#)

The risers will be considered not uniform after finished flooring of any kind is installed. The greatest riser height shall not exceed the smallest by more than  $\frac{3}{8}$ ". R311.7.5.1

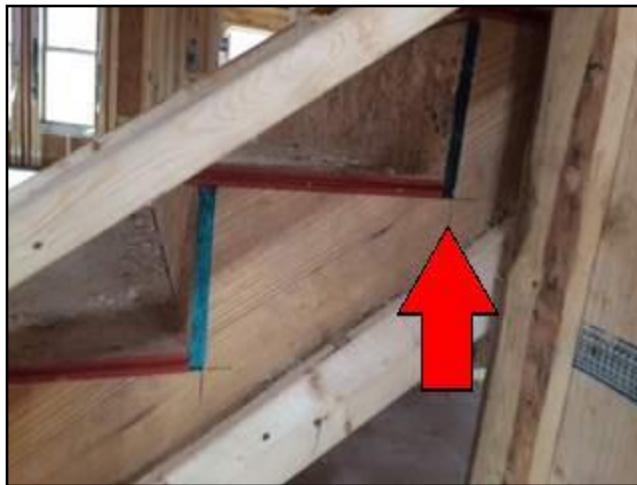
44.

**28. Condition:** • Stringers have been overcut throughout the staircase.

**Task:** Repair

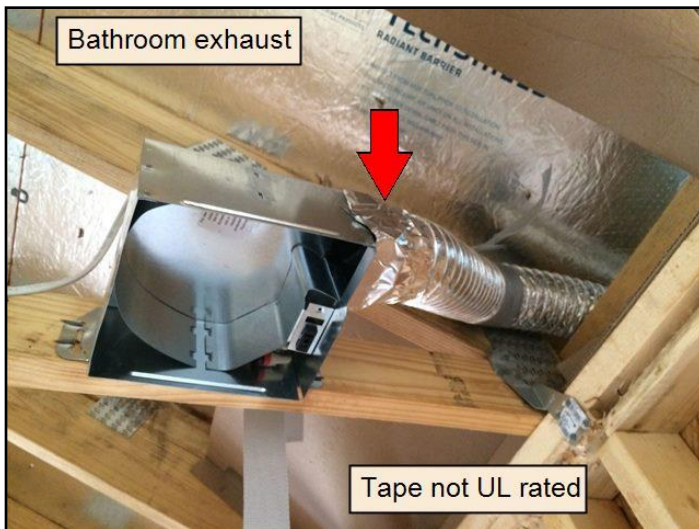
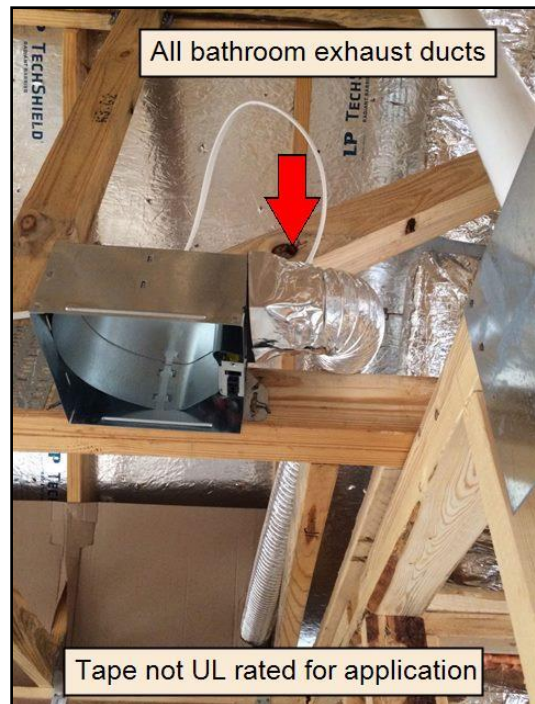
**29. Condition:** • In All 3 bathrooms exhaust ducting has been sealed using a non UL rated tape. M1601.4

**Task:** Correct
