Your Inspection Report

2001 Main Street
Decatur, GA

RE: Report No. 48984, v.2
2001 Main Street
Decatur, GA

SEWER SCOPE

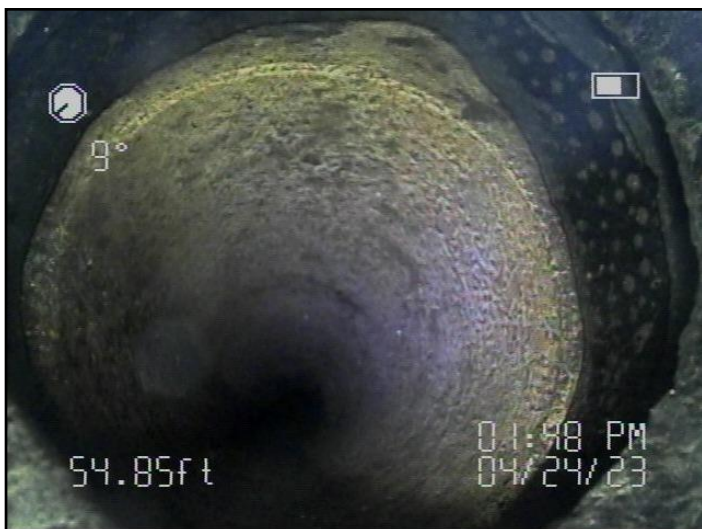
2. ABS to Cement at 54.85'.

Waste piping material: • PVC waste line typically has an expected lifespan of 100 years or more. • ABS waste line typically has an expected lifespan of 50 to 80 years. • Cement drain lines were used predominately up to the 1970's. Any Cement drain lines in use will be near the end of its expected life and may require repairs or replacement in the near future.

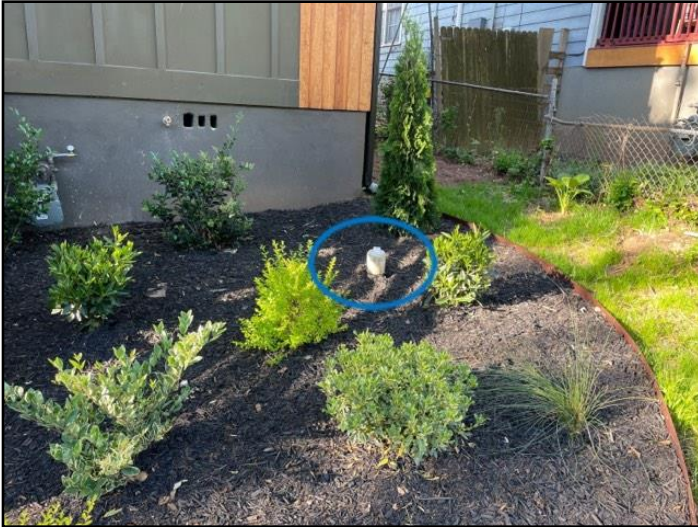
4. Exterior cleanout.
