Your Inspection Report

6695 Juliet Drive with THERMAL
Atlanta, GA 30328

INSPECTION DATE:
Monday, May 8, 2023

RE: Report No. 49158, v.2
6695 Juliet Drive with THERMAL
Atlanta, GA
30328

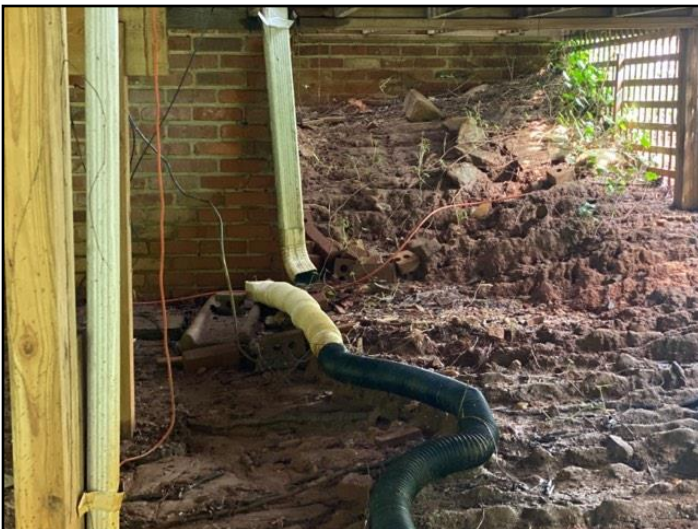
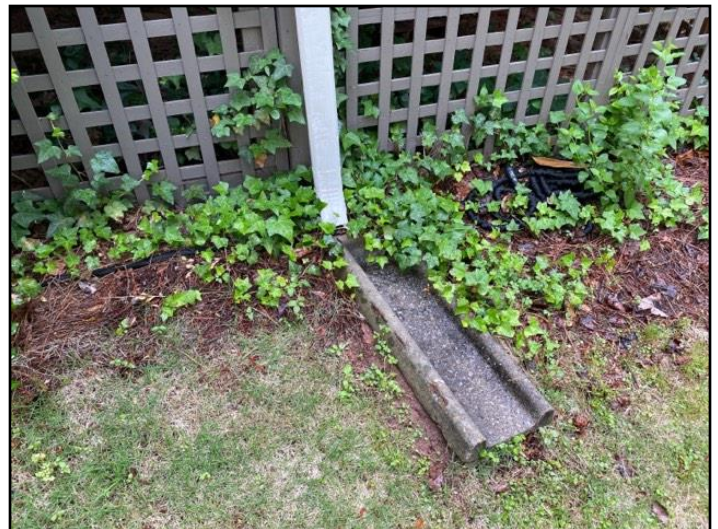
8. Discharges Too Close to the Building

9. Discharges Too Close to the Building

Time: Immediate

Cost: Minor

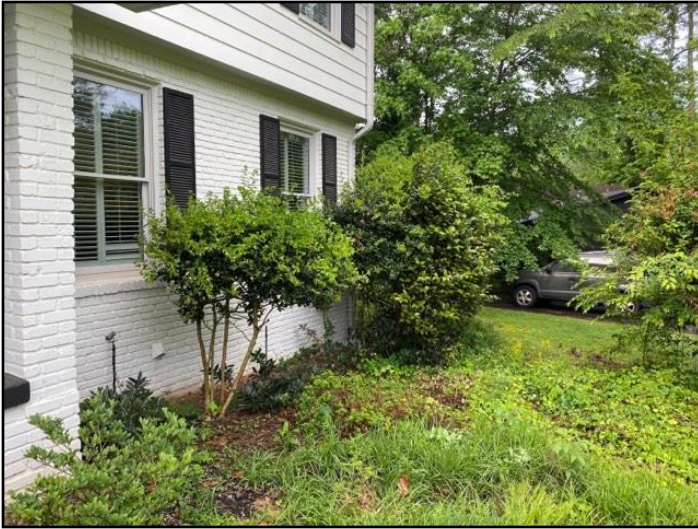
20. Trees or Shrubs too close to building

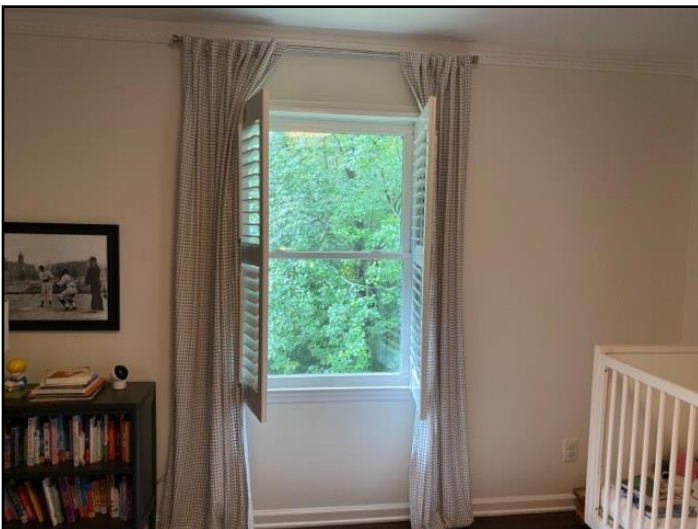
77. Windows Painted Shut

42. Condition: • Windows Painted Shut

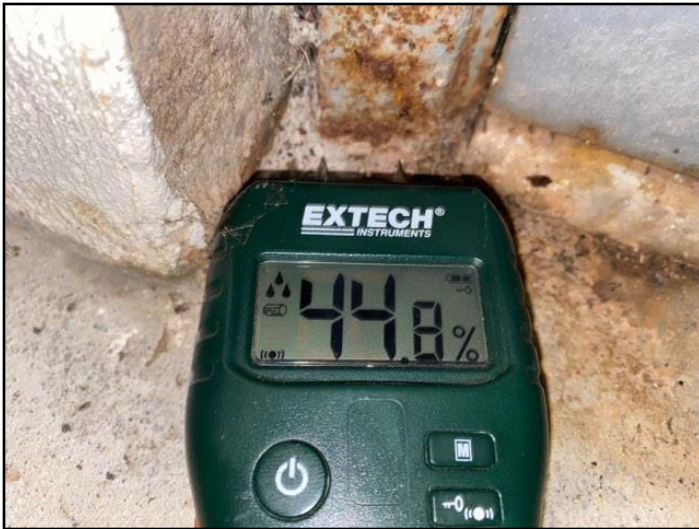
84. Dampness on floor or walls

47. Condition: • [Dampness on floor or walls](#)

Task: Consult with a foundation or waterproofing company

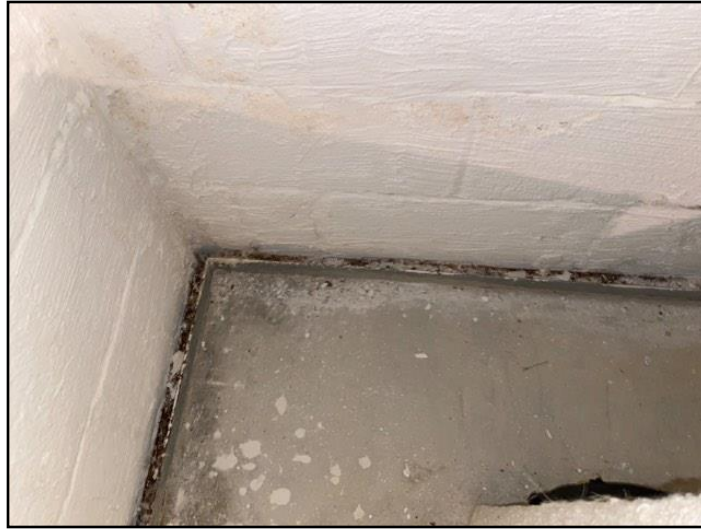
90. Floor patched or Trough at floor perimeter

49. Condition: • Floor patched or Trough at floor perimeter

Evidence of previous moisture issues and corrective action taken. Request disclosure of work performed, contractor information with any transferable warranties.
