Your Inspection Report

2009 Happy Drive with THERMAL
Atlanta, GA

INSPECTION DATE:
Wednesday, May 10, 2023

PREPARED BY:
Mark Kinzie, Certified Thermal Inspector

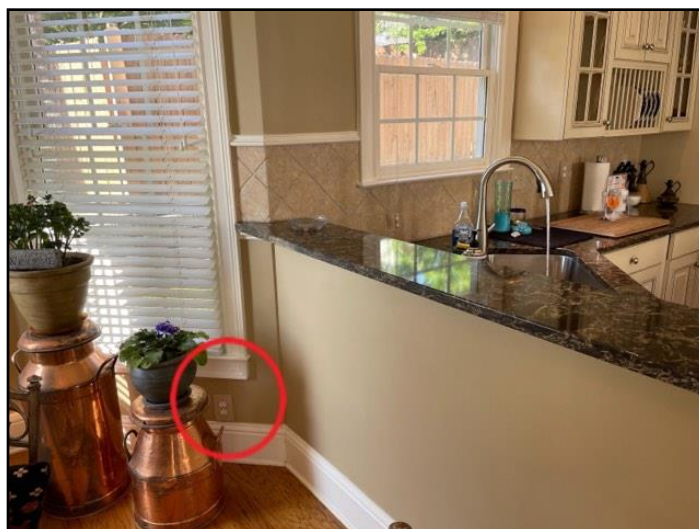
22. No GFCI/GFI (Ground Fault Circuit...)

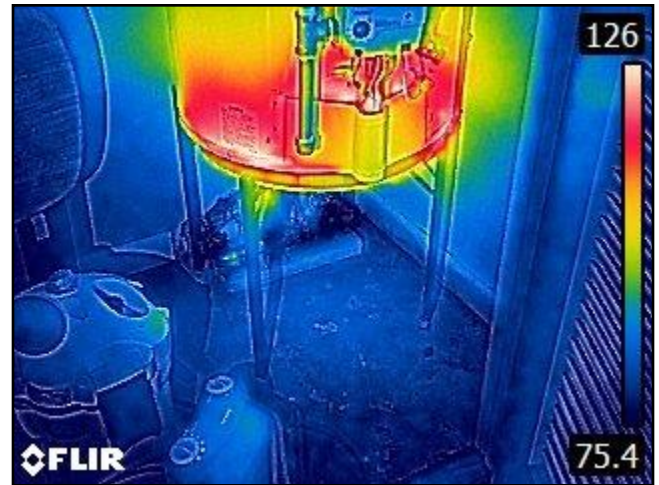
98. Plumbing Fixture/Penetration: No issues

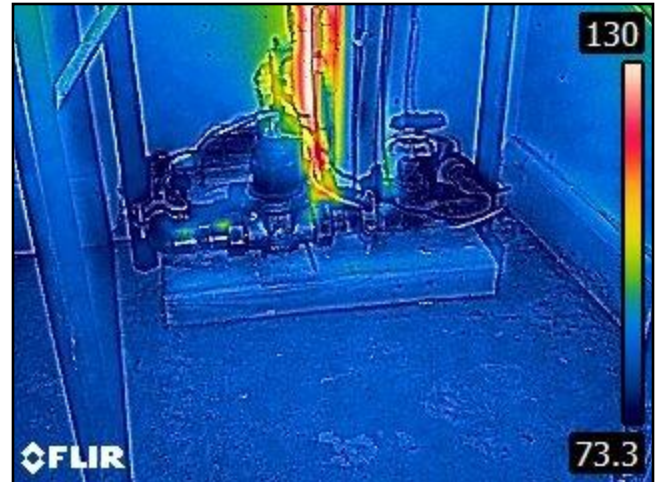
100. Plumbing Fixture/Penetration: No issues
