Your Inspection Report

6695 Juliet Drive with THERMAL
Atlanta, GA 30328

INSPECTION DATE:
Monday, May 8, 2023

RE: Report No. 49158, v.2
6695 Juliet Drive with THERMAL
Atlanta, GA
30328

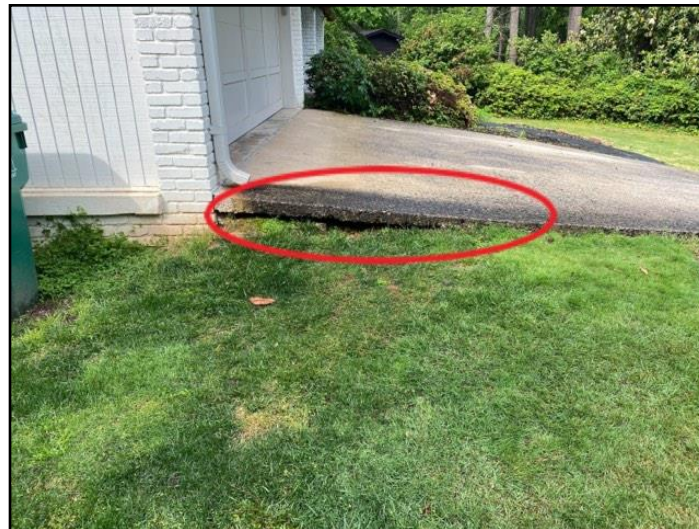
22. Soil Erosion

Task: Be Advised Monitor

Time: Ongoing

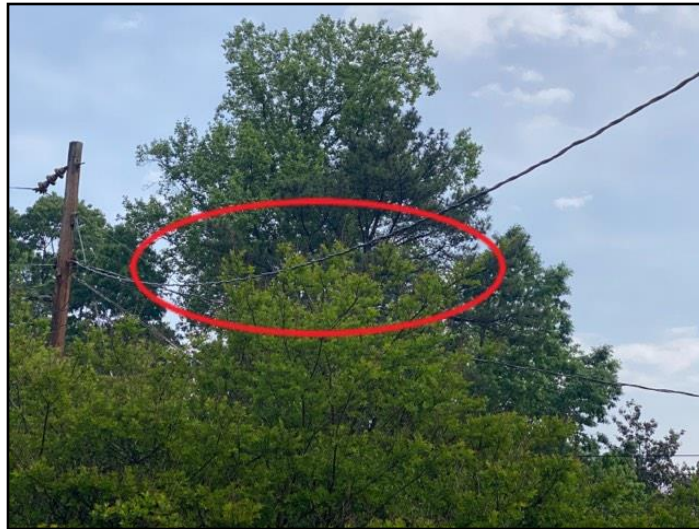
27. Branches/Vines on Service

Time: Immediate

Cost: Regular maintenance item

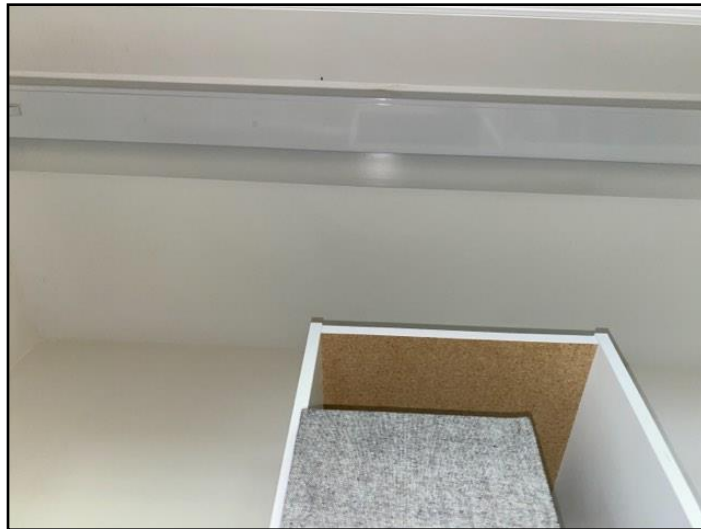
33. Inoperative

Time: Immediate

Cost: Minor

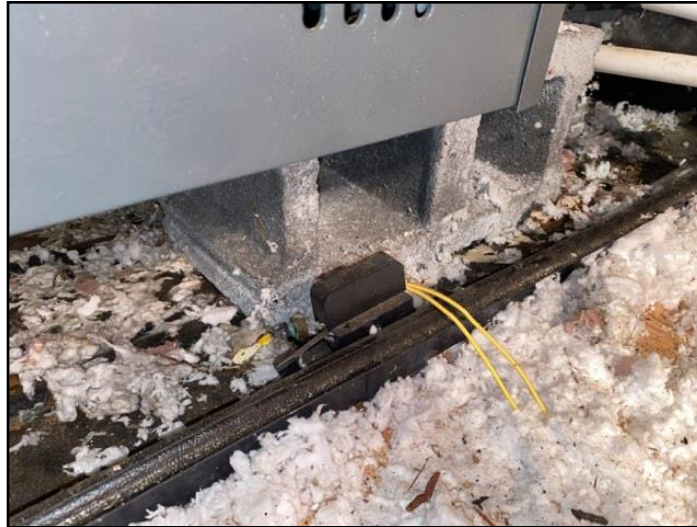
47. Debris in auxiliary pan

Time: As Soon As Possible

Cost: Regular maintenance item

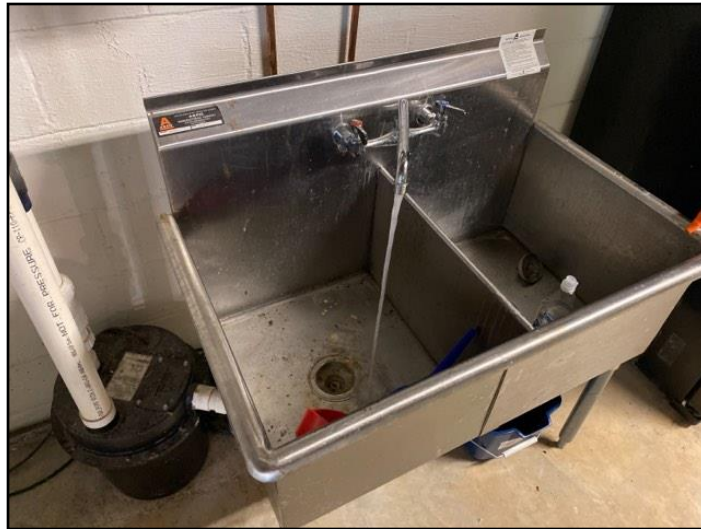
62. Slow drains

38. Condition: • [Slow drains](#)

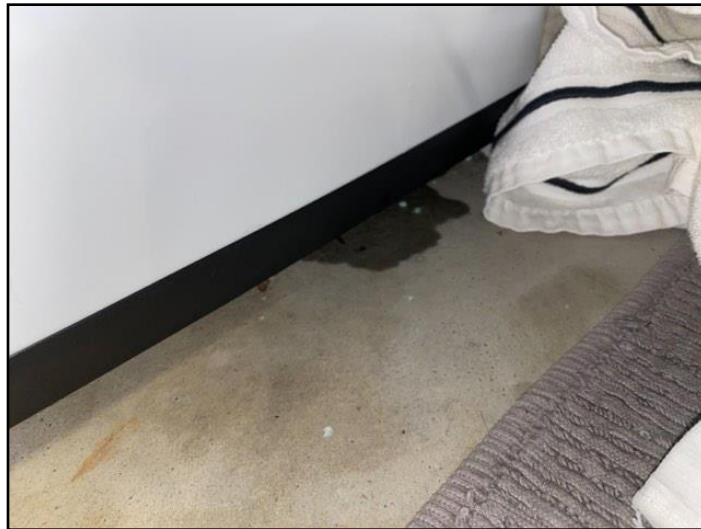
91.

50. Condition: • Possible leak

Task: Correct
