Your Inspection Report

2009 Happy Drive with THERMAL
Atlanta, GA

INSPECTION DATE:
Wednesday, May 10, 2023

PREPARED BY:
Mark Kinzie, Certified Thermal Inspector

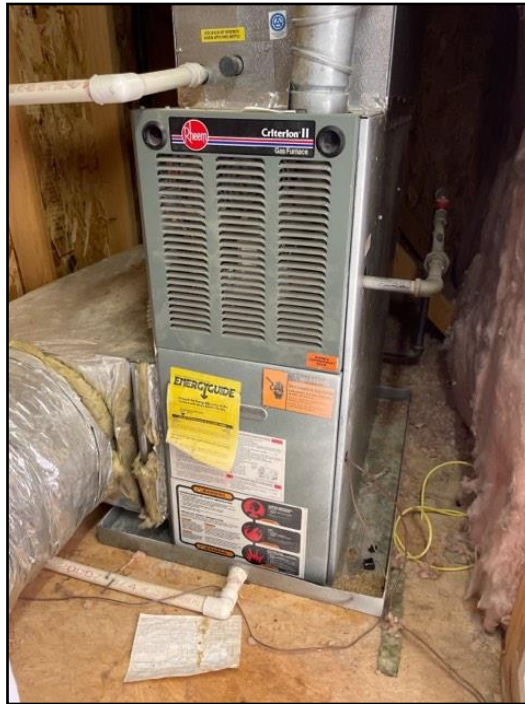
26. Noisy

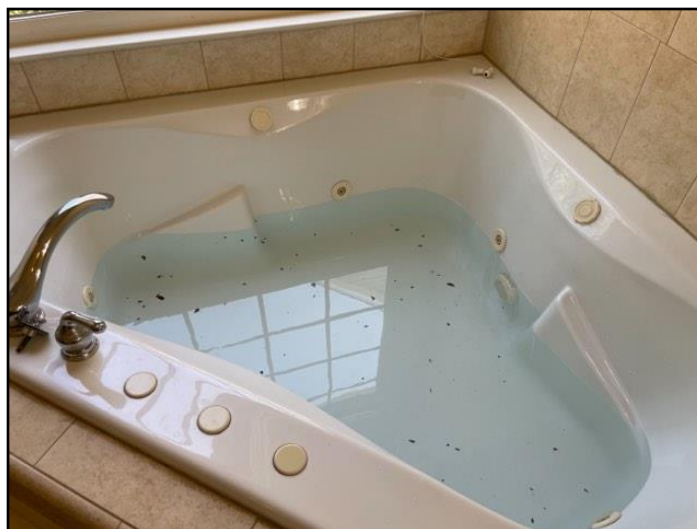
47. Dirty water from the jets

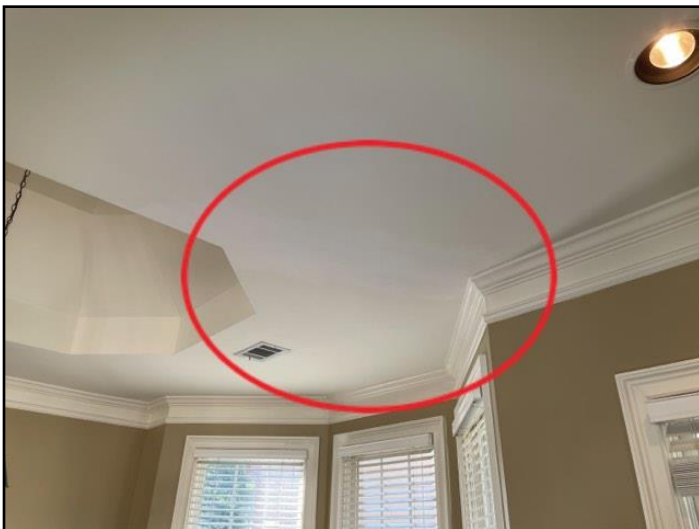
27. Condition: • Patched/Painted Areas

Patches and painted areas in ceilings are usually from previous leaks that may no longer be leaking or only leak in certain circumstances. Suggest consulting with the seller as to why these repairs have been done.

52. Patched/Painted Areas

Task: Request disclosure

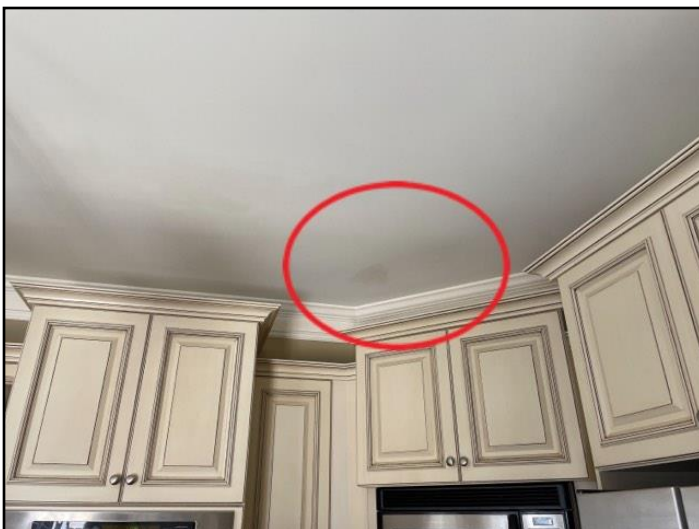
29. Condition: • Patched/Painted Areas

Patches and painted areas in ceilings are usually from previous leaks that may no longer be leaking or only leak in certain circumstances. Suggest consulting with the seller as to why these repairs have been done.

57. Patched/Painted Areas

56. Patched/Painted Areas

Task: Request disclosure

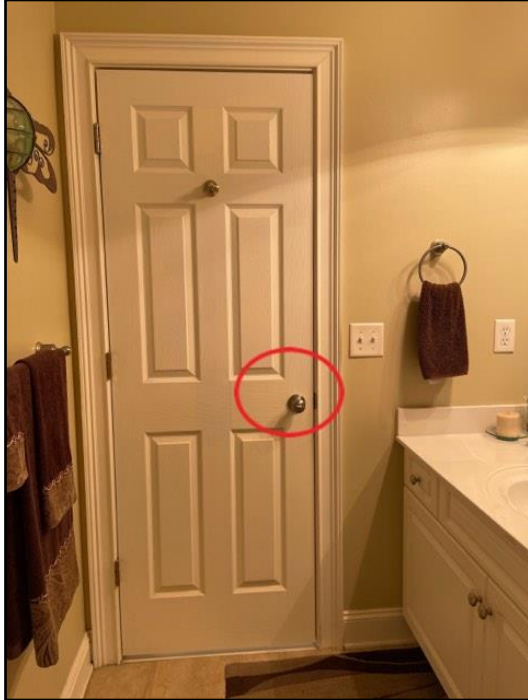
34. Condition: • [Does Not Latch Properly - Click for DIY Video](#)

61. Does Not Latch Properly - Click for DIY Video

Task: Adjust
Time: Discretionary
Cost: Minor

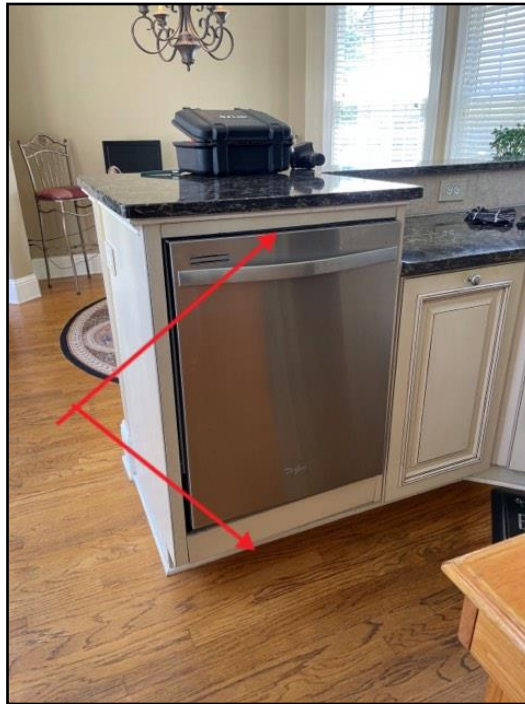
63.

35. Condition: • Loose or damaged trim

Task: Repair

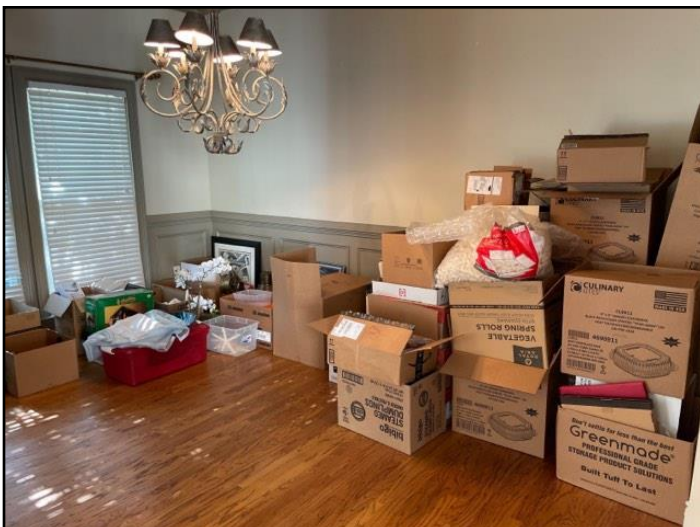
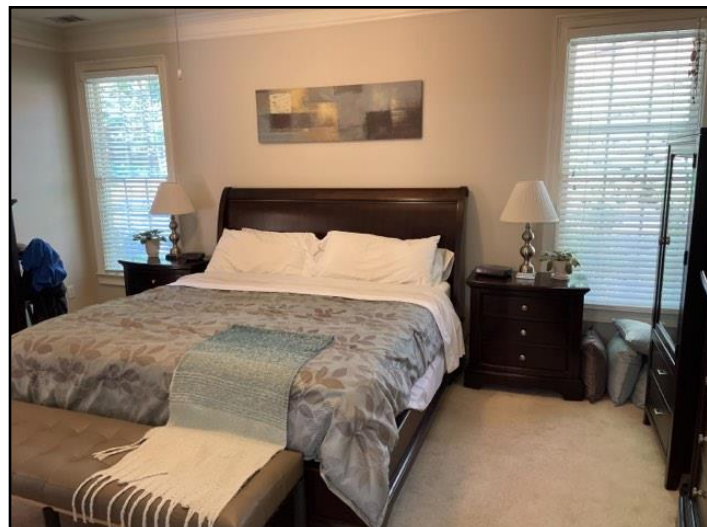
Inspection limited/prevented by:

65. Storage/furnishings

66. Storage/furnishings

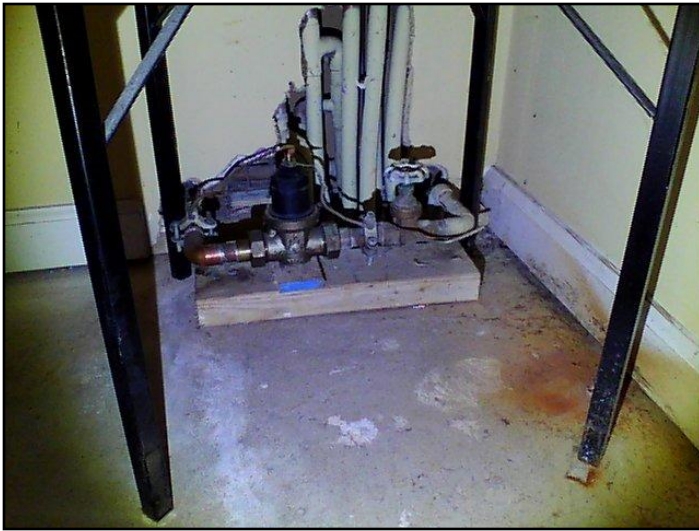
99. Plumbing Fixture/Penetration: No issues
